# Feedback to the EU Fitness Check of the Water Framework Directive

Wetlands International – European Association, March 2019

**Successes of EU Water Framework Directive implementation**  
**Evidence of river restoration measures improving ecological conditions**

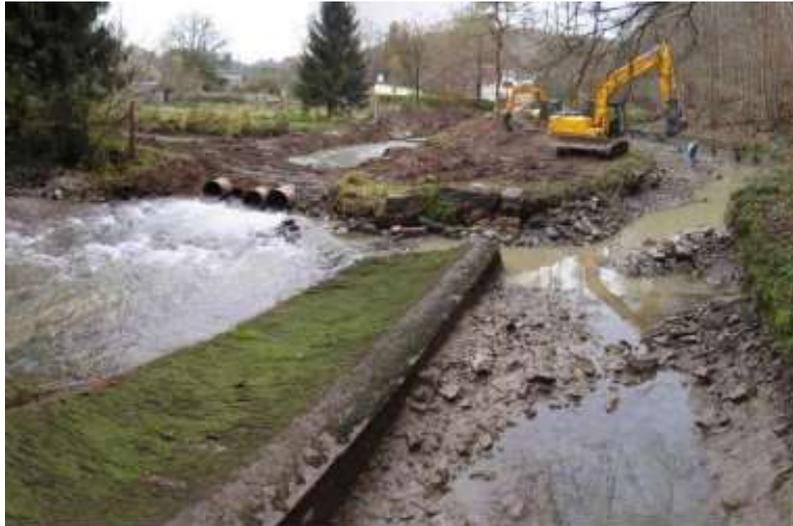
*Figure 1. Works for weir removal at Spontin (source: LIFE project «Walphy» Layman's report).*

Monitoring activities showed that the habitat heterogeneity was enhanced, with a consequent improvement of the ecological conditions in most of the study sites. Significant examples are the weir removal at Spontin and the remeandering in Emptinale along the Bocq. At the Spontin site an improvement was observed of the number of rheophilic species, biomass and number of individuals. In addition, the value of the biotic index of fish integrity (IBIP, indicating the ecological quality based on the attributes of fish communities) moved from 19 to 23, i.e. from good to high quality class. On the other hand, no significant improvements were measured through the sampling of benthic macroinvertebrates. At the remeandered site in Emptinale, a significant improvement was observed of both the benthic macroinvertebrates-based index IBGN (Indice Biologique Global Normalisé, indicating the ecological quality for benthic macroinvertebrates) from moderate to good quality class and the fish-based index IBIP from good to high quality class (Castelain et al., 2018).

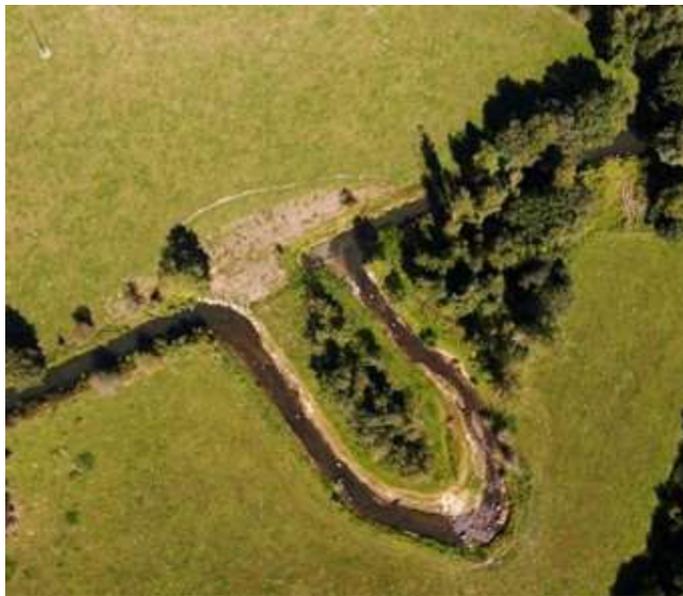
*Figure 2. Re-meandering of the Eau Blanche at Boussu-en-Fagne (source: LIFE project «Walphy» Layman's report).*

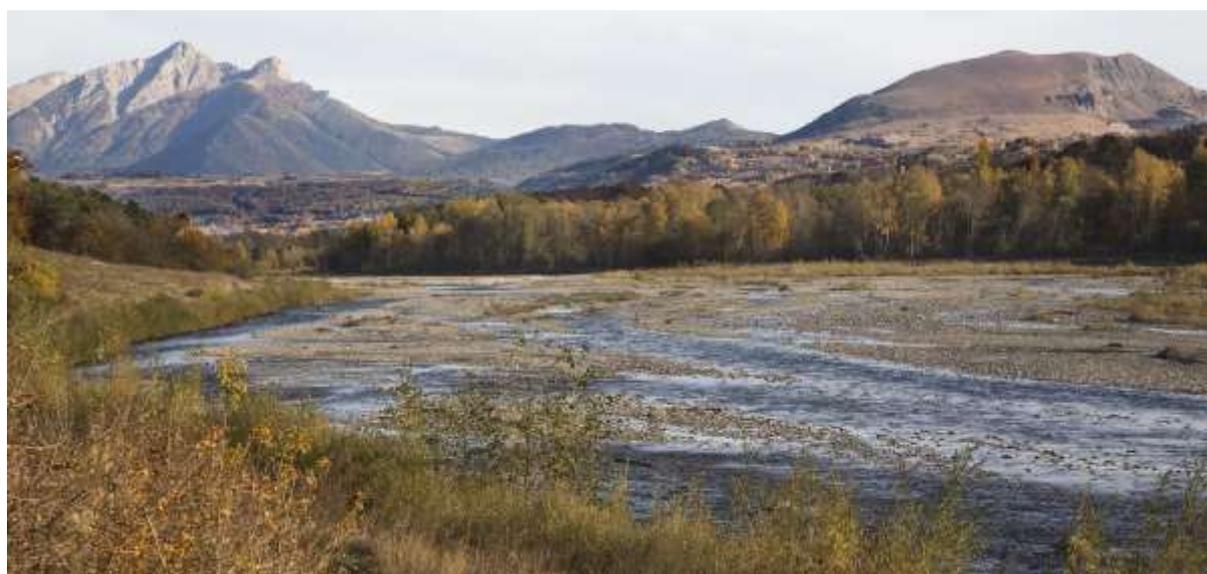
Figure 3. The Drac in the restored reach (October 2017, picture by Bruno Boz).

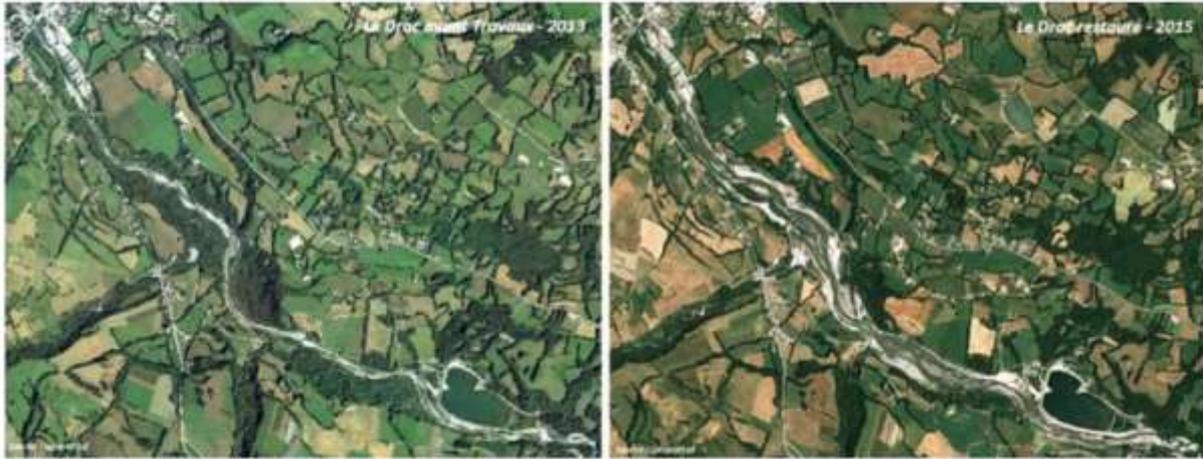
*Figure 4. On the left panel, aerial view on the single channel Drac prior the 2013 intervention; the Champsaur dam can be recognized in the bottom right corner. The river flows towards the top of the picture. On the right panel, the same reach after the intervention (source: French geoportal).*

Several elements were considered in the assessments carried out before the intervention, ranging from morphodynamics, to habitats and aquatic fauna. The project established a 10-year monitoring program on morphology and ecology. Innovative monitoring methods are planned for evaluating the evolution of the channel morphology: bedload tracing program using active ultra-high frequency RFID technology, repetitive high-resolution topographic surveys of the restored reach and high-frequency qualitative survey of channel changes using time-lapse cameras. The first morphologically relevant flood (15/11/2015) triggered the development of braided channel morphology.

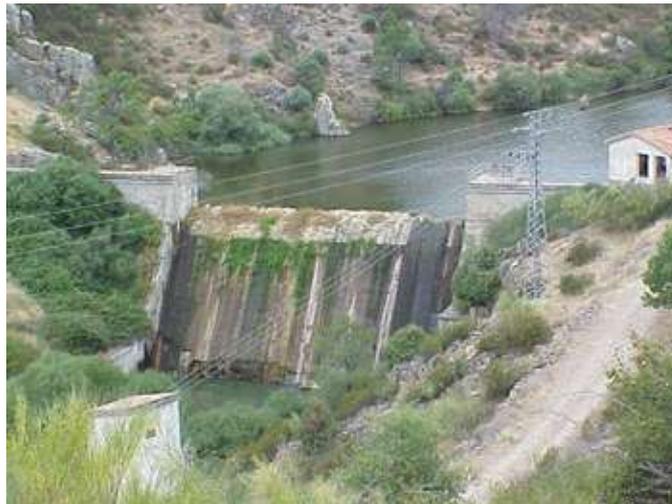
Figure 5. The Robledo de Chavela dam (source: Tajo River Basin Authority – Confederación Hidrográfica del Tajo).

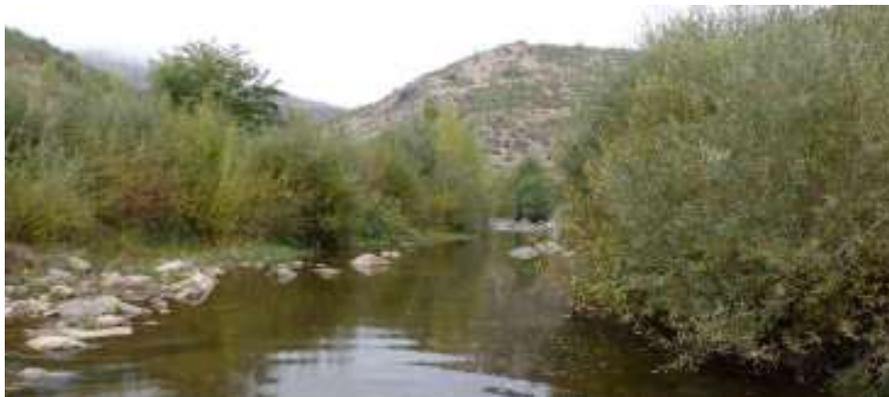
Figure 6. Riparian vegetation inside the old reservoir in 2018 (source: Tajo River Basin Authority – Confederación Hidrográfica del Tajo).

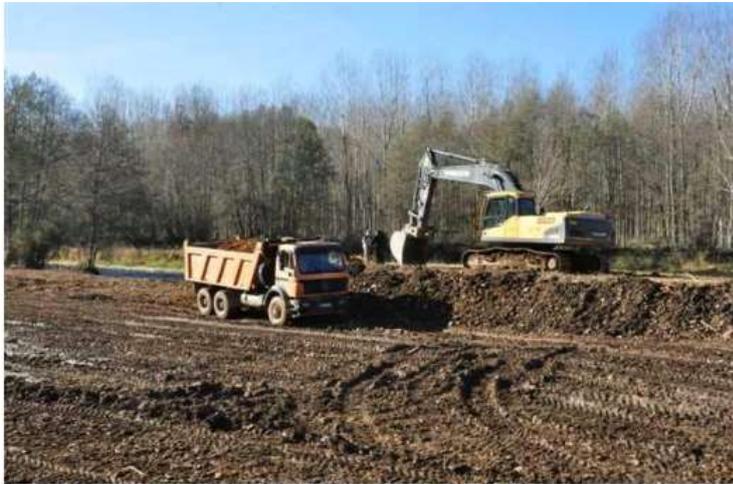
*Figure 7. An artificial levee is lowered to recover lateral connectivity (source: Duero River Basin Authority – Confederación Hidrográfica del Duero).*

Rock armoring of river banks and earth embankments were removed from more than 13 kilometers of river channels. Some earth embankments were set-back along 5 kilometers of river channels, and other barriers such as groynes were lowered. 10 kilometers of secondary arms were reconnected and/or directly restored. Moreover, a riverbank vegetation buffer was created along 7.2 hectares that were reconnected to the river. Other in-channel obstacles, namely weirs, were modified to restore continuity for fish fauna and sediments. The project approach was very different from the experience of the local stakeholders, who were initially reluctant, especially towards expropriation. However, an

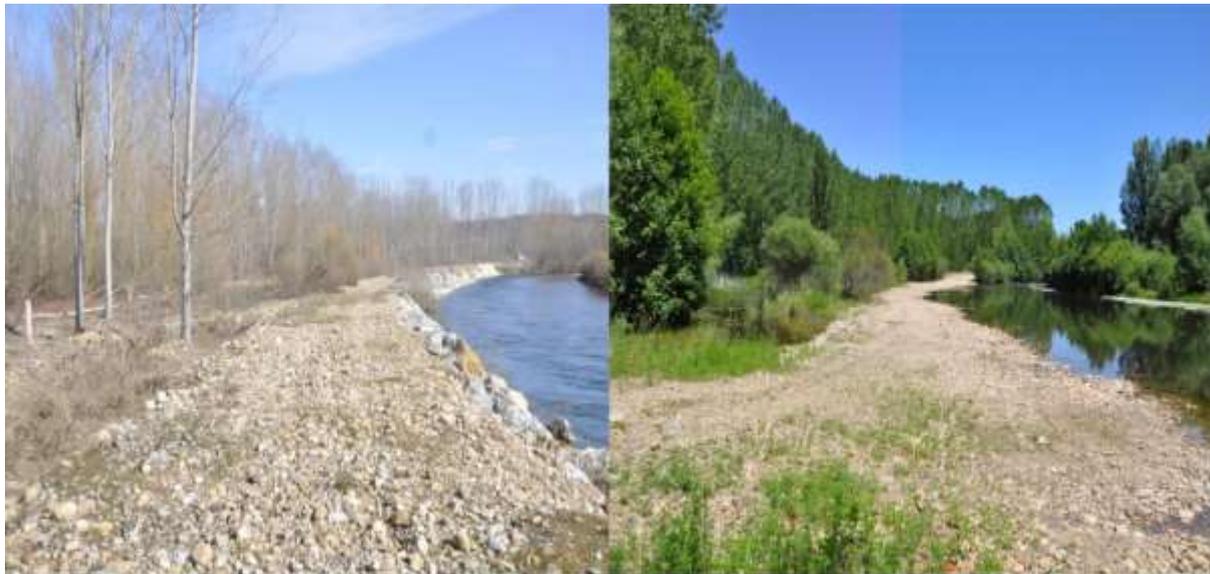
*Figure 8. River bank protections were also removed along the river: on the left, the situation before the project; on the right, the river is reconnected to its floodplain (source: Duero River Basin Authority – Confederación Hidrográfica del Duero).*

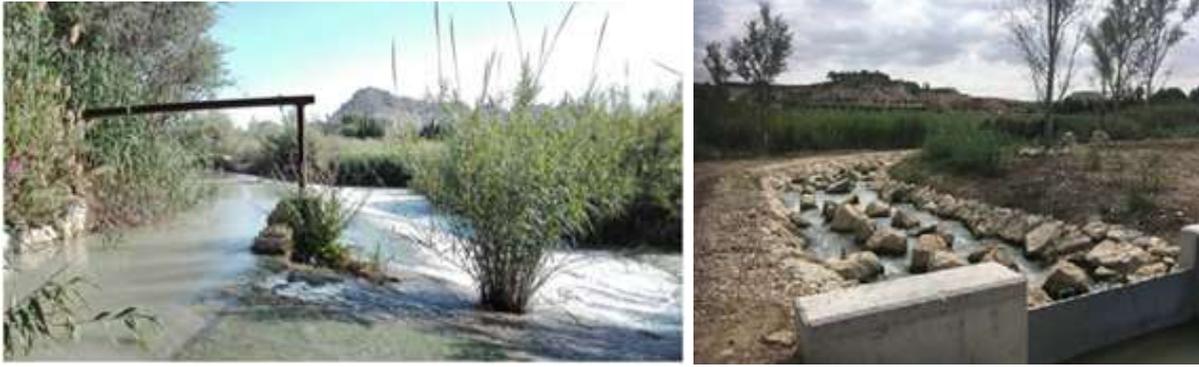
*Figure 9. Azud Archena weir, on the left, and lateral fish bypass for Archena weir, on the right (source: Segura River Basin Authority – Confederación Hidrográfica del Segura).*

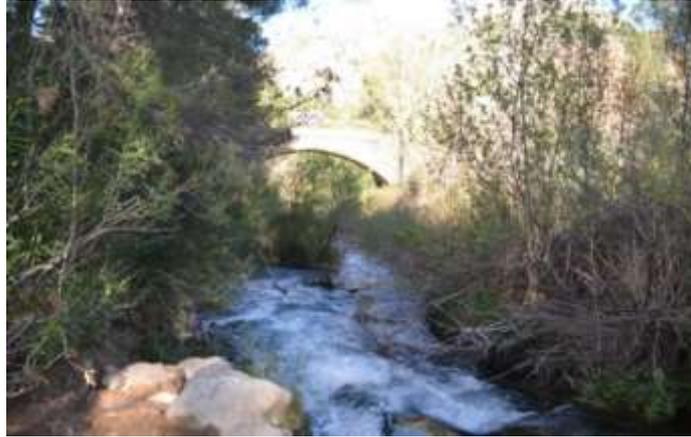
*Figure 10. Restored flow along the Turia River (source: Pedro Merino Monzonis /RÍOS CON VIDA - Comunidad Valenciana).*

The increase of the minimum flow had positive consequences on macrophytes, benthic macroinvertebrates and fish. The populations of brown trout (*Salmo trutta*) are recovering thanks to the newly created areas with loose gravel that are of fundamental importance for spawning. The abundance and diversity of benthic macroinvertebrates improved due to in-channel habitat diversification. Moreover, the condition of the riparian forest is also improving.

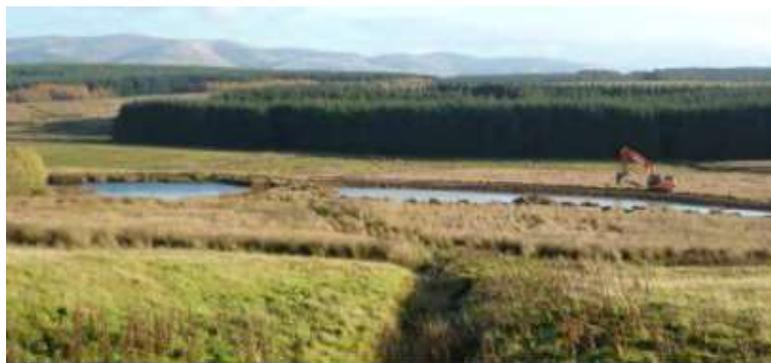
*Figure 11. Construction of new ponds in the upper catchment (source: Eddleston Water Interreg Project Report 2016).*

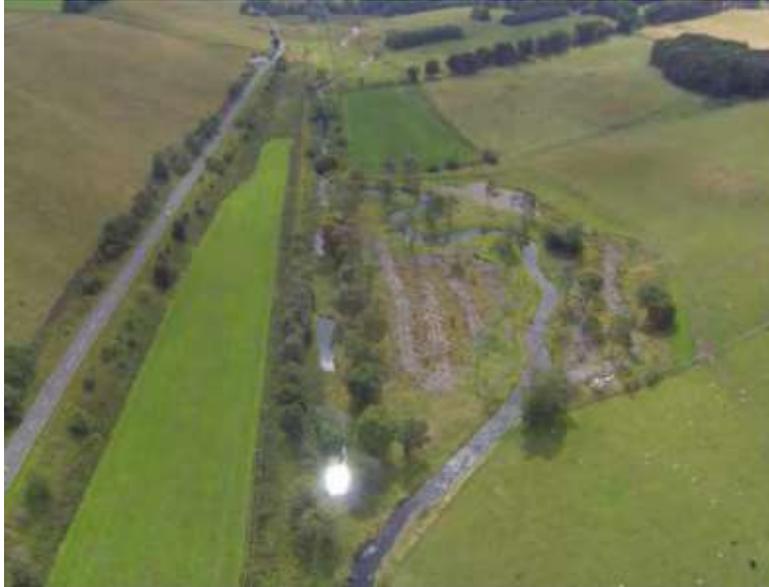
Figure 12. Re-meandered section of Lake Wood, with the old channel on the left (source: Eddleston Water Interreg Project Report 2016).

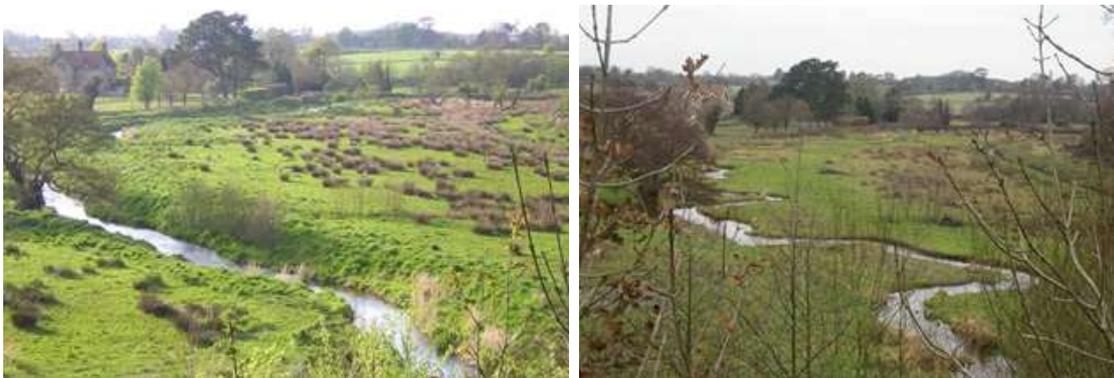
*Figure 13. Re-meandered reach of the River Glaven at Hunworth: (a) In January 2009, prior to the rehabilitation project, on the left, and in December 2010, after re-creation of meanders in August on the right (source: modified by Champkin et al., 2018).*

Embankment removal and remeandering alongside the River Glaven at Hunworth has created a more natural flood-pulsed hydrological regime, characterised by regular, short duration inundation of the floodplain meadow, with consequent positive effects for river–floodplain ecosystem functioning (e.g. enhanced habitat connectivity and heterogeneity). Before and after control intervention (BACI) surveys of floodplain plants, aquatic macrophytes, benthic invertebrates and fish were carried out, but some results are still to be published. Vegetation surveys recorded a significant increase in macrophytes' richness following the 2 phases of restoration. Remeandering at Hunworth Meadows had no significant impact on stream invertebrate biodiversity, but when invertebrates in backwaters along the floodplain were included, a significant increase in invertebrate diversity was detected, due to the addition of several 'pond-associated' species (Sayer 2014). The backwaters were also colonised by amphibians and these observations demonstrate that the presence of these standing waters significantly enhanced biodiversity in the river–floodplain system. Restoration interventions increased the density and biomass of brown trout (*Salmo trutta*), but had no significant short-term impact on other fish populations (Champkin et al., 2018).
