Natural Water Retention in the Ramabujas Stream catchment near Toledo

The road to reduce peak flows and increase infiltration

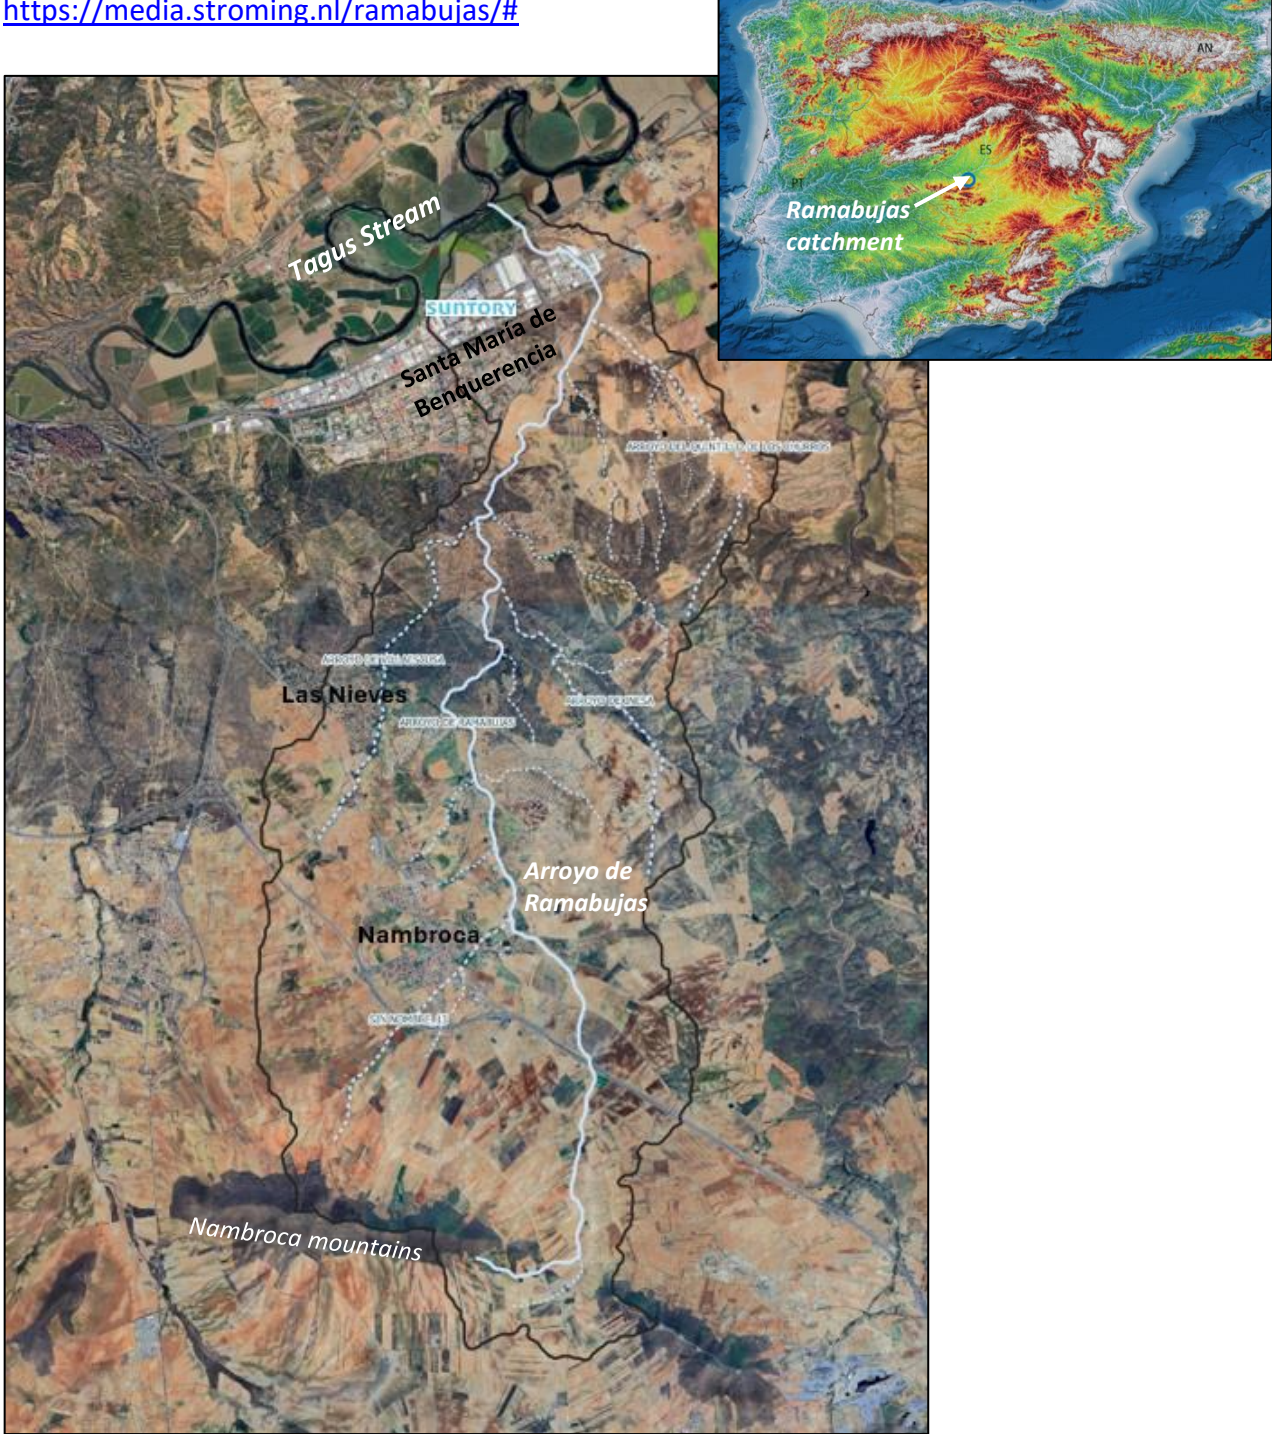
Figure 1: Topographical map of the Arroyo de Ramabujas catchment in the region Castilla – La Mancha near Toledo (central Spain). Two small villages (Nambroca and Las Nieves) are located within the catchment. The industrial district Santa María de Benquerencia, home to the Suntory factory, is located in the most downstream area of the Ramabujas catchment, near its confluence with the stream Tagus.

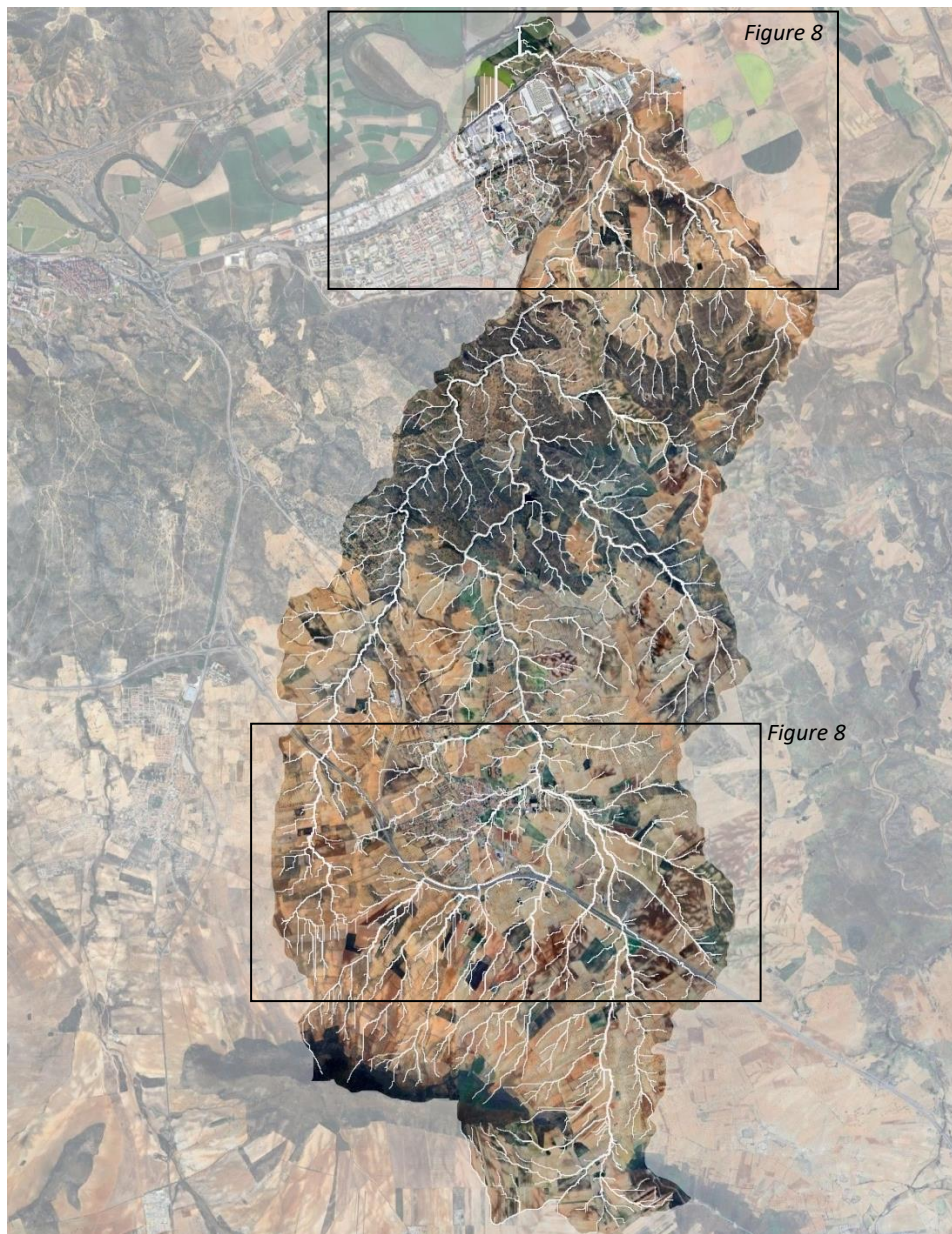
Figure 7: Drainage network of the Ramabujas stream catchment derived from 10-m DEM.

The Ramabujas drainage network as shown in Figure 7 was calculated from 10-meter resolution digital elevation data. The drainage network consists of the main stream, *Arroyo de Ramabujas*, along with its primary tributaries: *Arroyo de Villaescusa*, *Arroyo de Inesa* and *Arroyo del Quintillo de los Churros*. This drainage system is characterized by ephemeral flow, with water typically present only after rainfall events. For most of the year, the streams are dry. Therefore, especially the headwaters of the drainage network shown in Figure 7, illustrate the direction of surface runoff more accurate in case of a rain event.

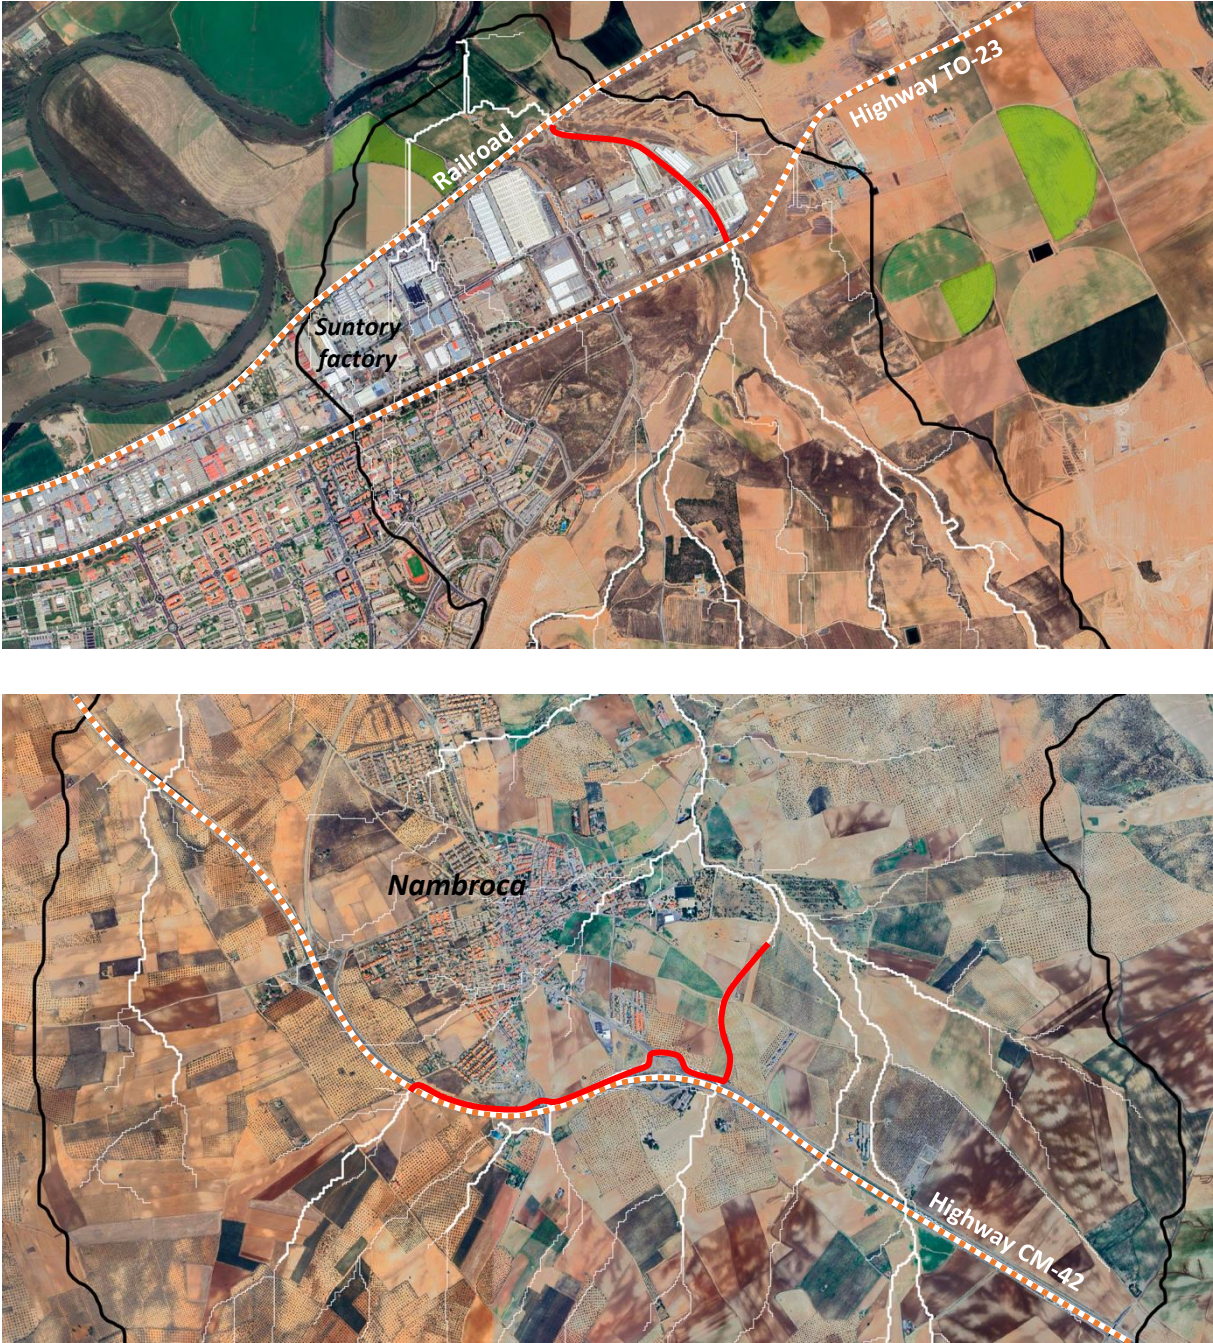
Figure 8: Culverts (where drainage lines cross the railroad and two highways) and artificial canals (red lines) in the industrial area of Santa María de Benquerencia (top), and around the village of Nambroca (bottom).

A notable feature of the Ramabujas drainage system is its partial obstruction by east-west oriented highways and railroad (Figure 8). To facilitate the passage of water underneath these elevated structures, runoff is directed through culverts. At these localities, the calculated drainage network was adjusted manually to account for passage through these culverts. Manual adjustment was also needed for the two artificial canal structures, one around/through the village of Nambroca, and the other one crossing the industrial terrain of Santa María de Benquerencia (Figure 8).

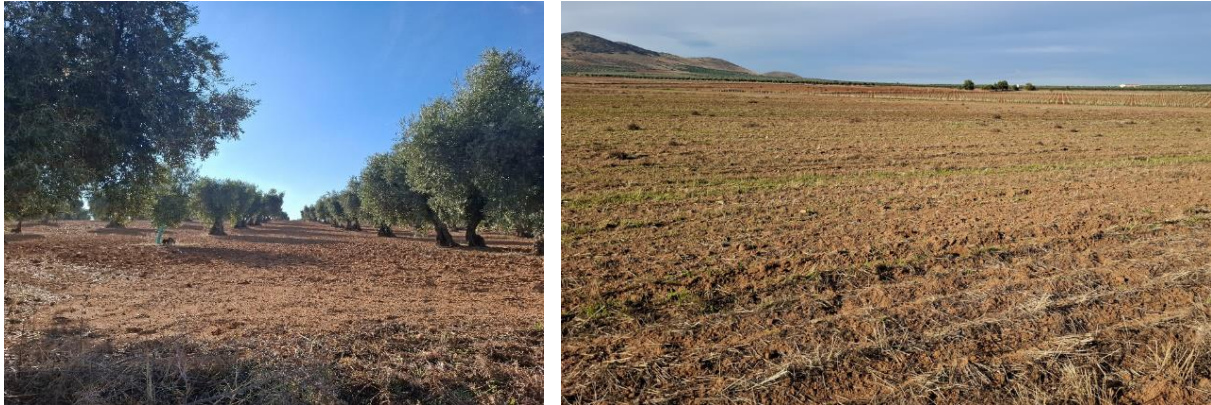
Figure 9: Olive groves (left) and wheat plots (right) are the dominant agricultural land uses in the Ramabujas catchment.

In the Ramabujas catchment, three types of agricultural land use dominate: olive groves, arable land, and fallow land (Figures 9 and 10). Various crops are grown in the fields, mainly winter wheat. After harvesting these crops in spring (~April), the fields typically remain fallow for the remainder of the year. In the olive fields, soils remain uncovered year-round, often lacking undergrowth such as grasses and herbaceous plants.

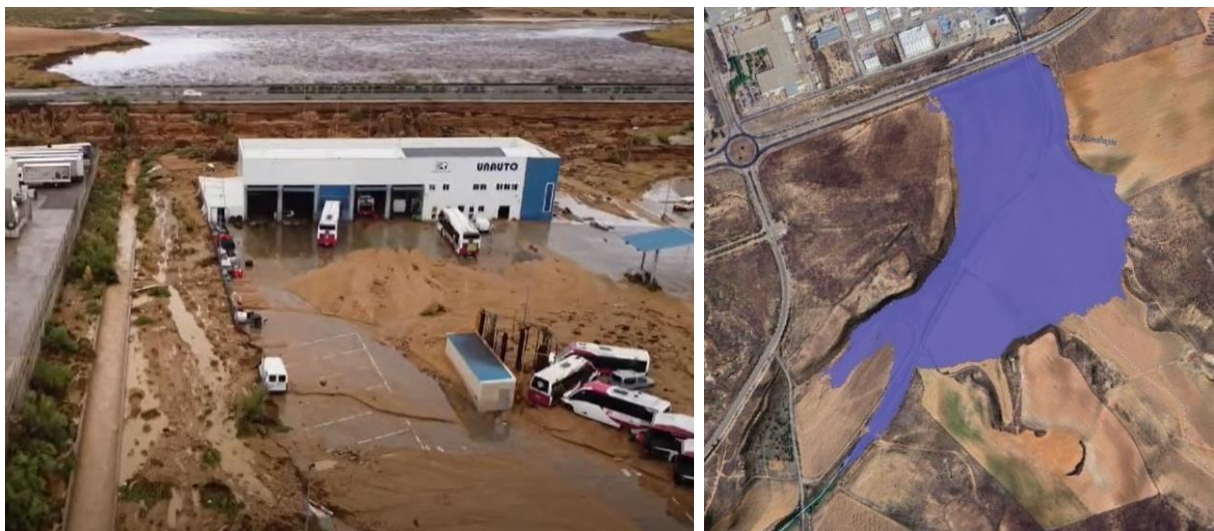
Figure 22: Based on the DEM (Digital Elevation Model) a reconstruction could be made of the lake that emerged during DANA (lake is visible in the left drone image from the day after). More than 900.000 m³ of water was temporarily stored on area of 28 ha (bottom).

During the DANA 2023 event, the culvert under the TO-23 highway was unable to efficiently discharge the water from the Ramabujas catchment, leading to the formation of a lake (see Figure 22). As the water level in the lake reached the height of the highway (484.5 meters), flooding began on the highway and spread into the nearby industrial area. A reconstruction of the lake's size suggests that approximately 28 hectares were flooded, with a total volume exceeding 900,000 m³ of water (Figure 22).

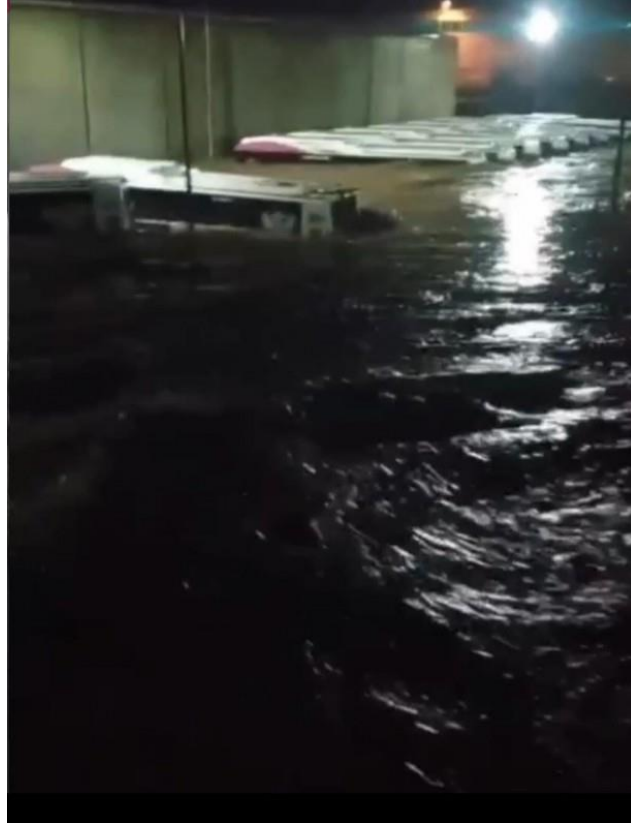
Figure 23: Flooding in the village of Nambroca on 3 September 2023 around 9:15 PM (Left). Flooding of Toledo bus terminal at the industrial site downstream of the Ramabujas stream on the same day at 10 PM (Right).

In terms of timing, flooding began around 9:15 pm in the village of Nambroca (Figure 23), and by 10 pm, the industrial zone—including the Suntory factory—was heavily inundated as water levels surpassed the height of the TO-23 highway (Figure 23). Given the short time gap between the peak of the DANA event and the flooding in the industrial zone, it is likely that the downstream subcatchments contributed the majority of the floodwaters.

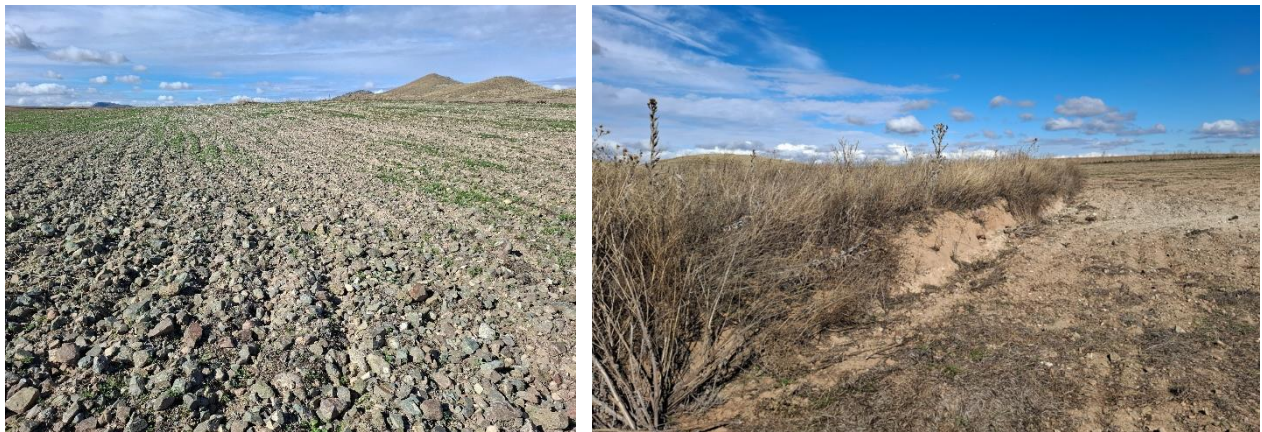
Figure 25: Continuous land degradation results in the loss of fine sediments (left) and organic material (right).

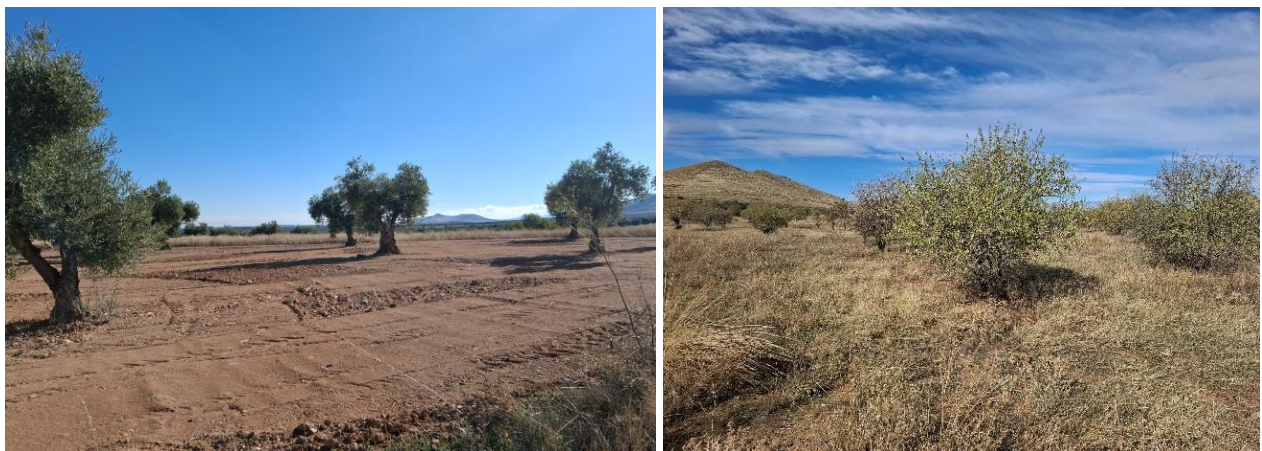
Figure 26: Abandoned almond fields (right) are more effective at preserving the soil through the protection of natural vegetation compared to the nearby olive groves (left).

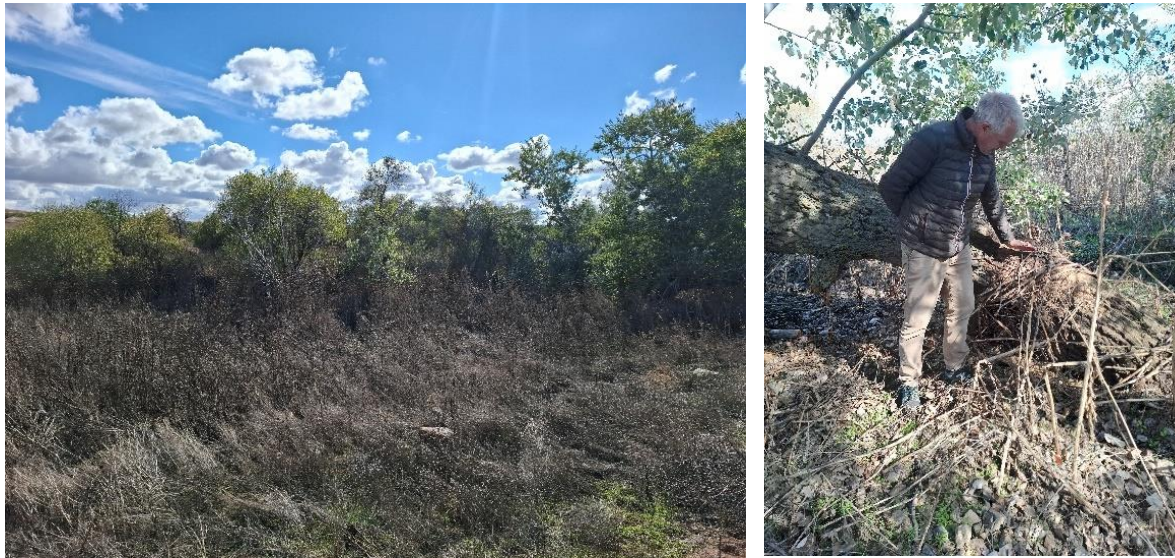
Figure 27: Sparse natural vegetation acted as a retention area, slowing the flow of water during the DANA event (left). The height of the water is indicated by the floodmarks on the trees (right).

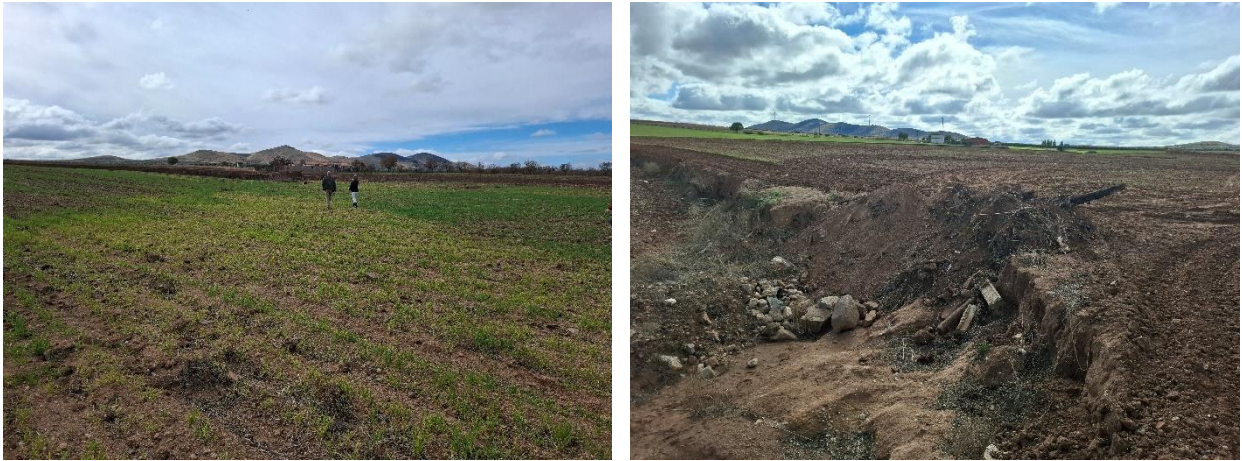
Figure 28: The course of the Ramabujas can be distinguished by the light green colour, the streambed is one with the arable land (left). 100 meters upstream the Ramabujas is not recognizable at all as erosion tracks are being erased and the streambed is ploughed (right).

If we follow the Ramabujas from sites 1 and 2 to the CM-42 Highway (site 3), floodmarks indicate high, but no extreme, discharges during the DANA 2023 event (5 m³/sec). The landscape was able to retain a significant amount of water coming from the upstream area. In this part of the catchment, the streambed of the Ramabujas is often unrecognizable in the field, as it runs through arable land and is therefore neglected as a stream.

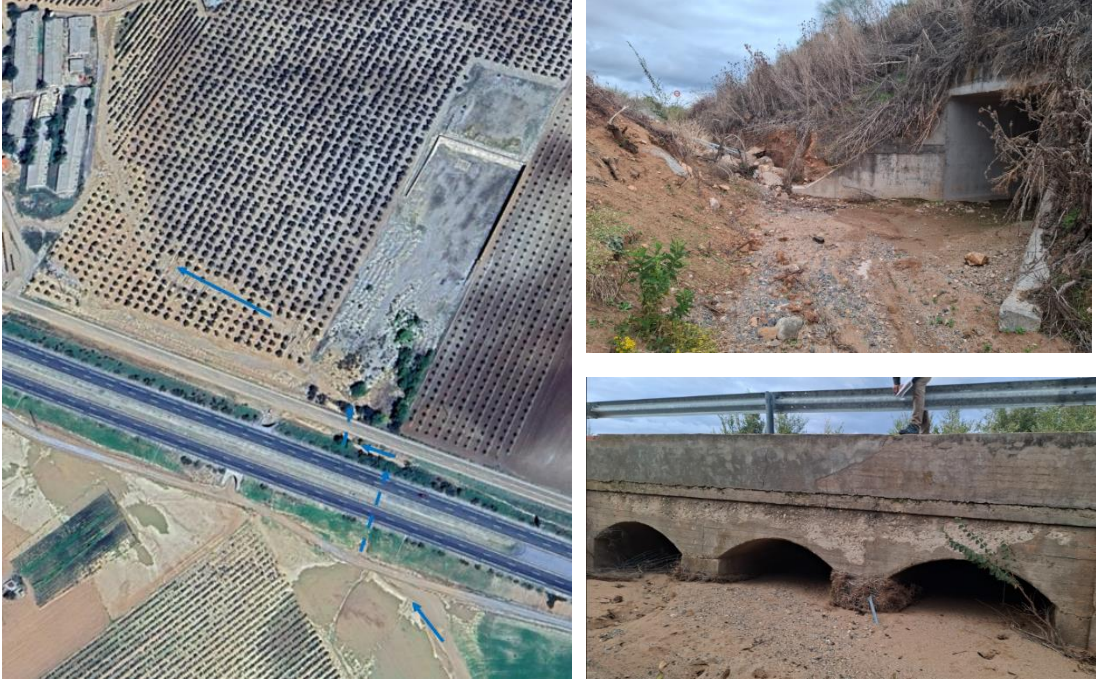
Figure 29: Ramabujas stream flows through a culvert under the highway (left) and bumps into the embankment of the secondary road (top right), where it flows 30 meters west through 3 small culverts to continue its way downstream (bottom right).

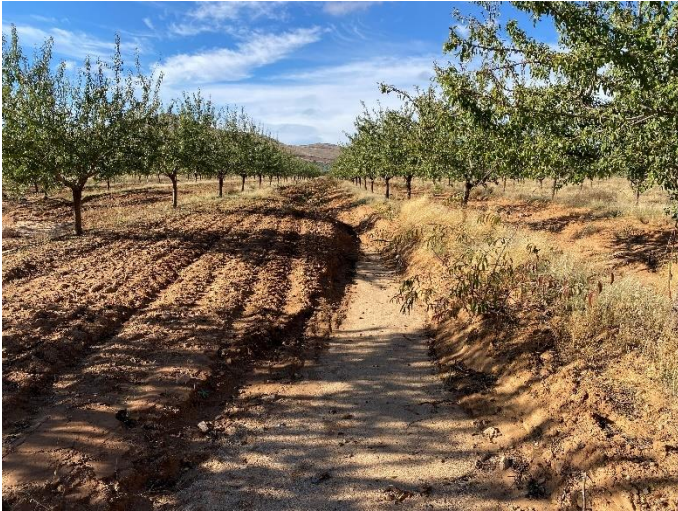
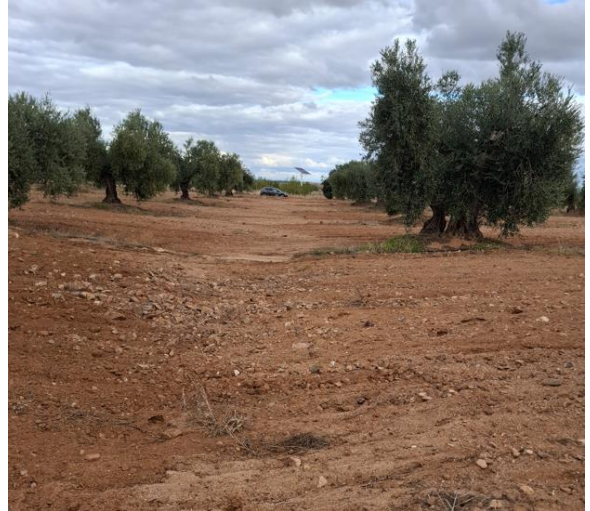
Figure 31: Severe erosion tracks through almond fields (left). Upstream olive fields are vulnerable for surface runoff (right)

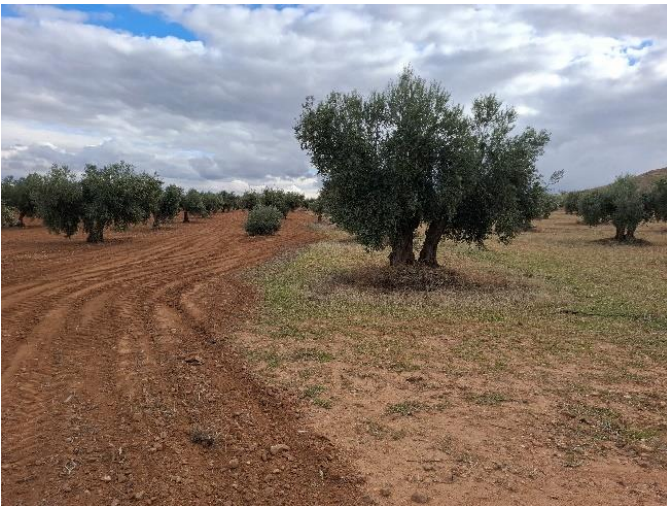
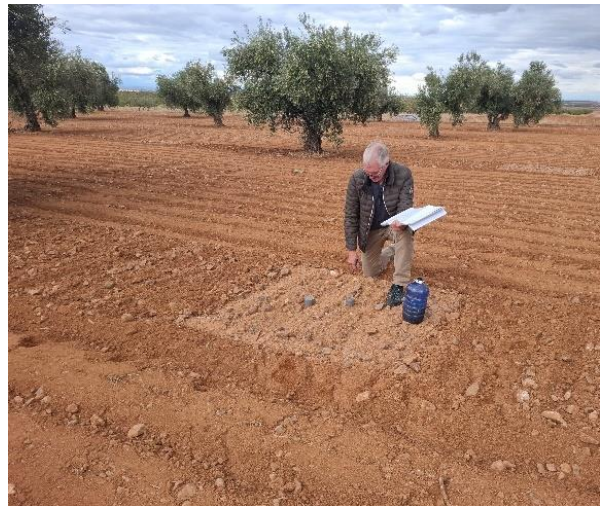
Figure 32: Ploughing of the olive fields removes the protection of grasses and herbs, leaving the soil fallow and reducing the infiltration capacity due to weather conditions.

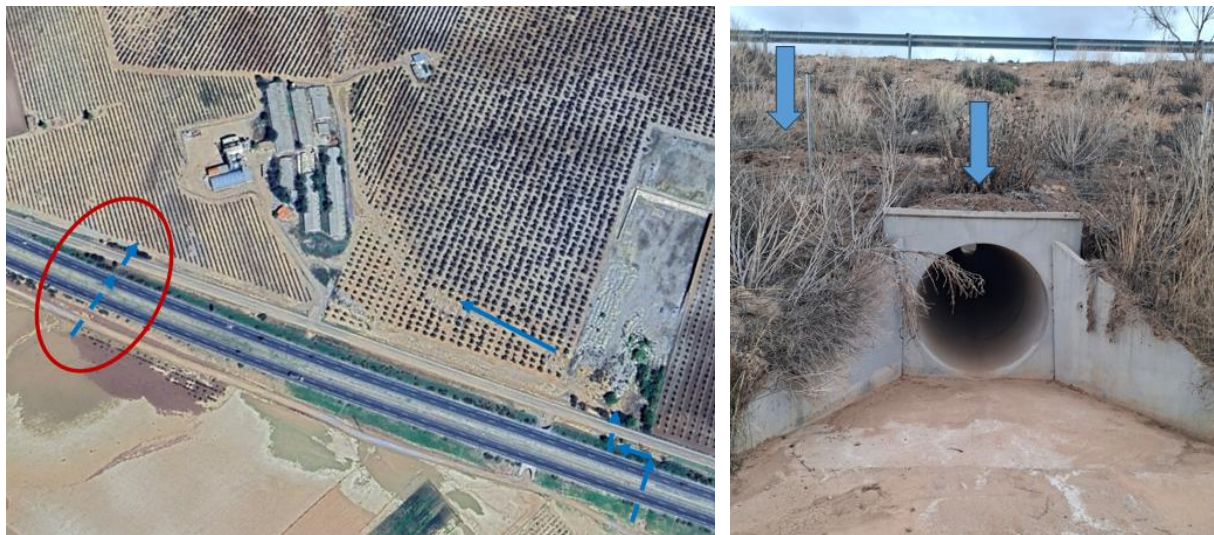
Figure 33: Flood marks under the highway revealed high water levels (3 meter) at the upstream side of the highway.

While the culverts are typically sufficient during average rainfall events, some of these structures turn out to be inadequate during extreme storm events. Especially considering the fact that these structures tend to become blocked by debris and sediment, radically reducing their capacity or even completely stopping the further passage of water.

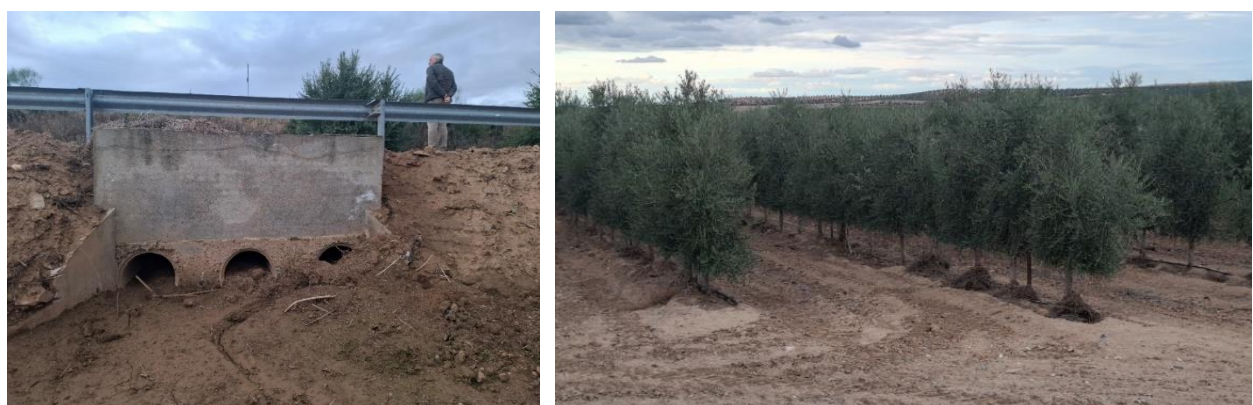
Figure 34: The smaller culvert under the secondary road couldn't handle the amount of water. The road flooded and water continued its way downstream through the olive field. Flood marks can be seen at the trunk of the trees.

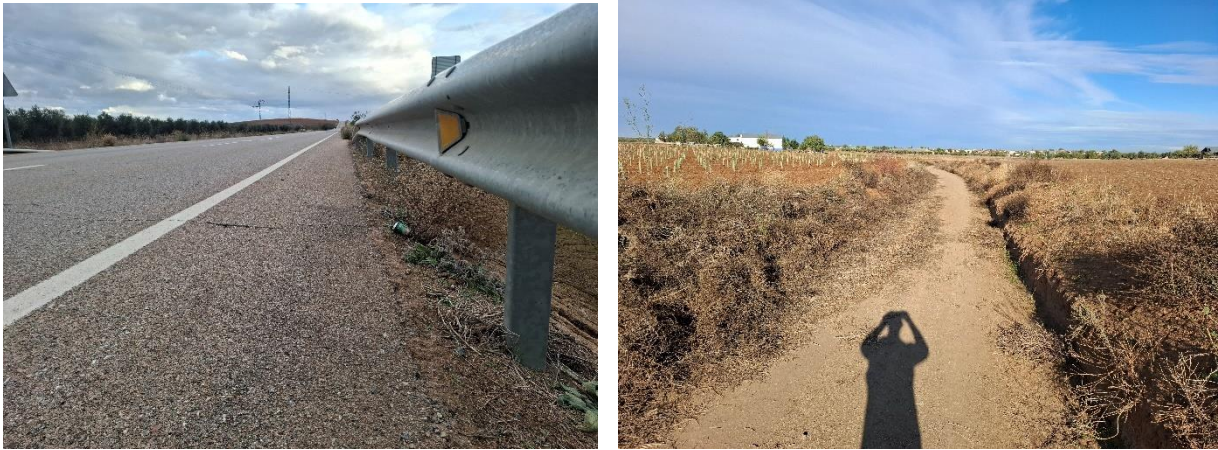
Figure 35: Surface runoff from paved and unpaved roads (field sites 6 & 7) contributed to the high discharge during DANA. Roads turned into streams.

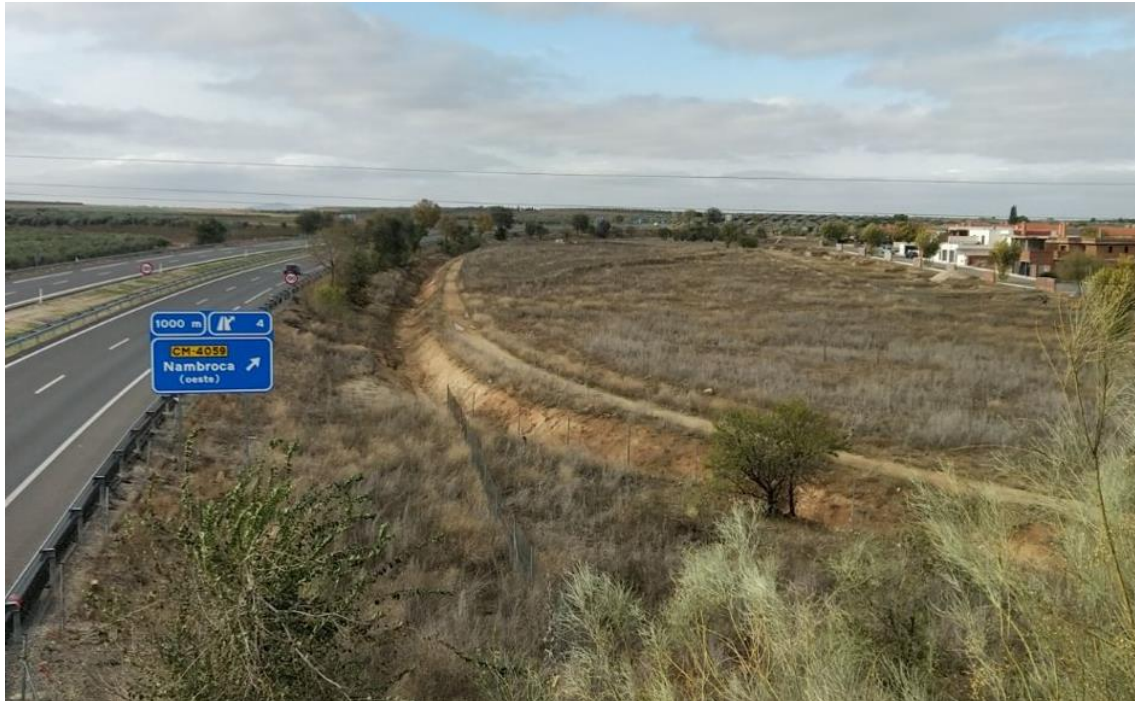
Figure 37: The artificial canal, build to protect the village, was not able to discharge the incoming water and breached at two locations.

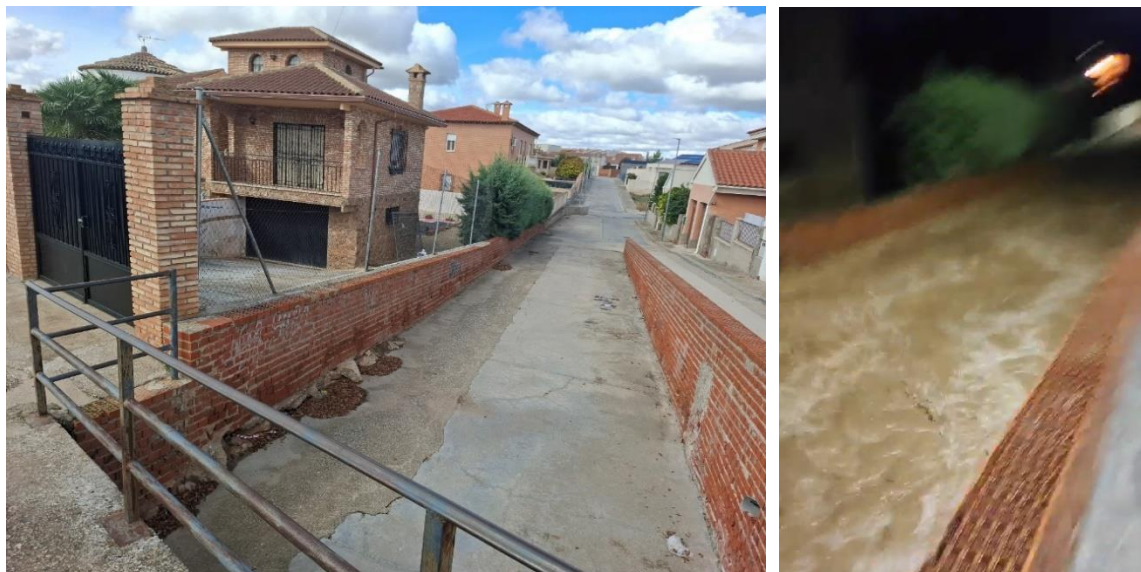
Figure 38: Calle de la Fuente turned into a stream during DANA 2023, flooding several streets and houses.

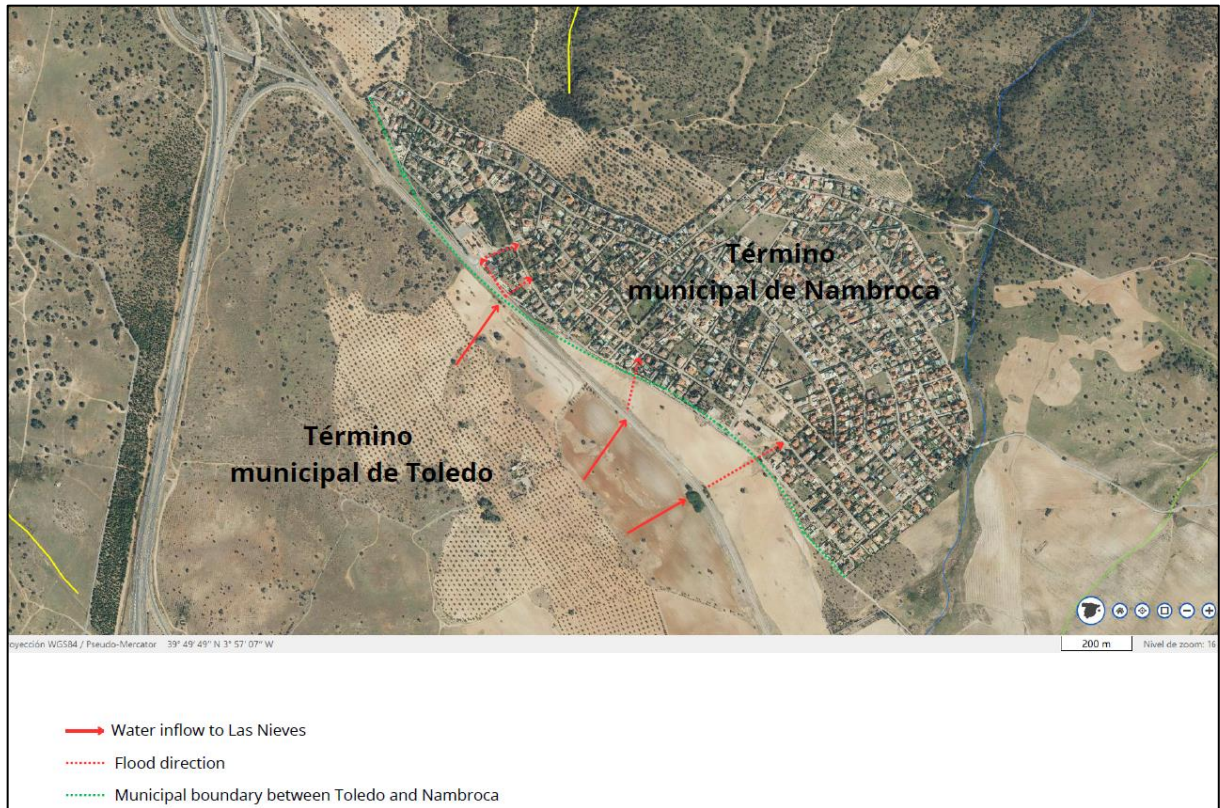
Figure 39: Flood map of Las Nieves during DANA 2023.

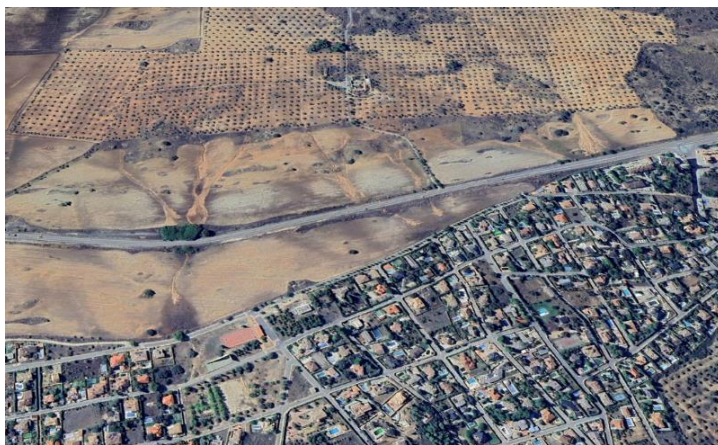
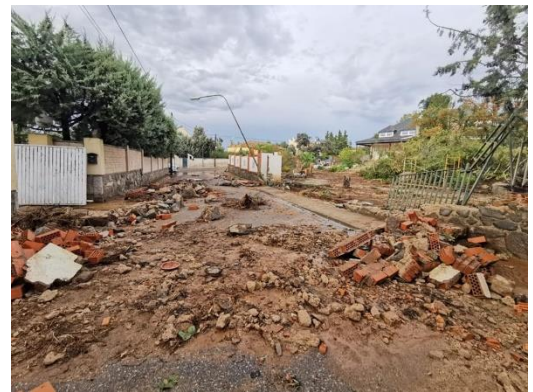
Figure 40: Satellite image of Las Nieves after DANA 2023 (left) and flood damage in the village (right).

In Las Nieves (39°49'44.5"N 3°58'00.1"W), during DANA events, mudflows enter the village from the west (Figure X). The area west of Las Nieves, which includes olive fields and arable land, is part of the municipality of Toledo and is characterized by a large percentage of bare soil.

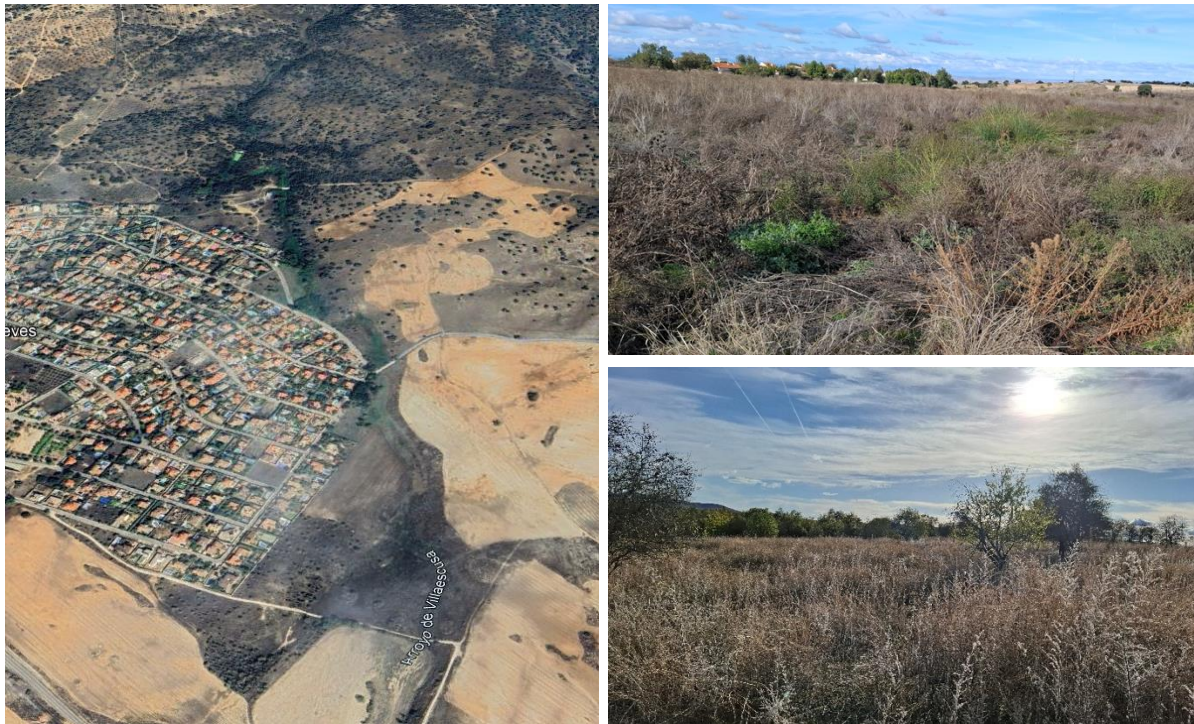
Figure 41: Natural valley of the Arroyo de Villaescusa flows east of Las Nieves in a natural valley (left), surrounded by a natural riparian zone (right).

East of the village of Las Nieves, the Arroyo de Villaescusa flows through a natural stream valley (39°49'19.0"N 3°57'23.1"W). Natural stream valleys are common to the incised streams of the Ramabujas catchment. The vegetation in these valleys helps retain and delay the flow of water during high discharge events.

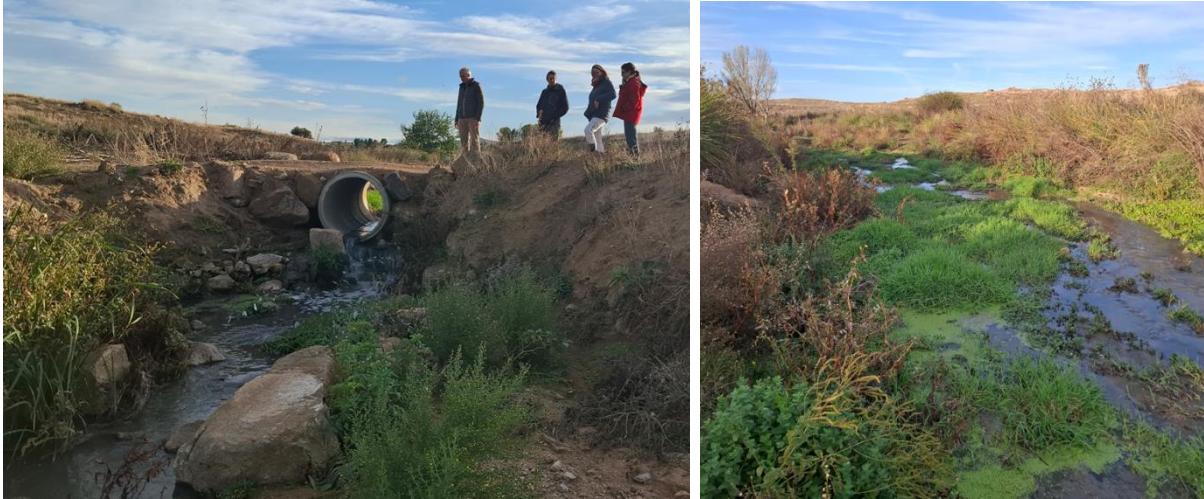
Figure 42: The Ramabujas flows through a natural valley downstream of Nambroca. The water quality during low discharges might be under pressure due to discharge of sewage water.

Downstream of Nambroca, the Ramabujas becomes an incising stream flowing through a natural valley. During our visit water was running through the streambed. The smell and colour of the water could indicate that wastewater from Nambroca might be discharged untreated in the Ramabujas. 39°48'57.4"N 3°56'12.6"W

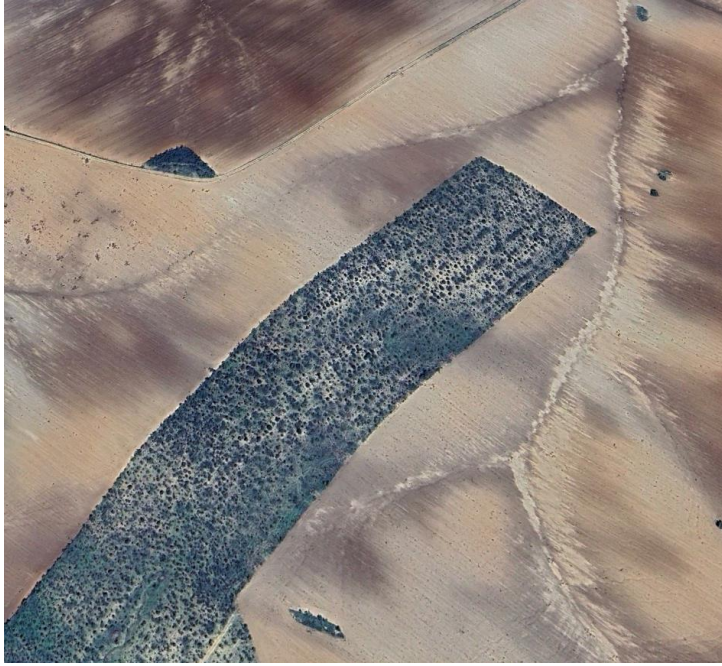
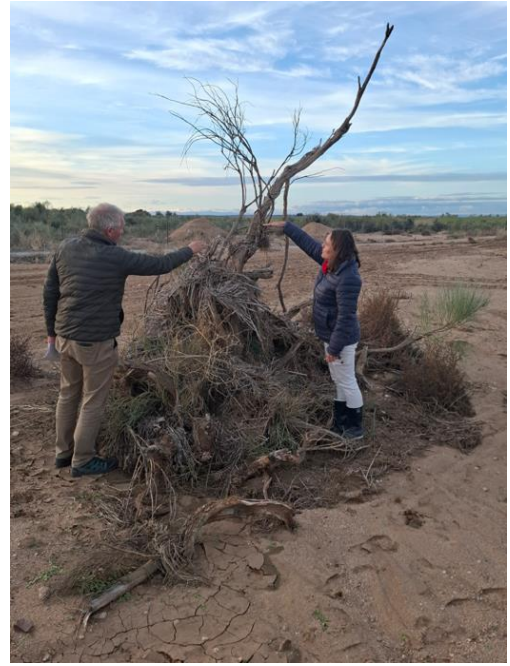
Figure 44: Ploughed erosion tracks on fallow fields visible in a satellite image taken two weeks after DANA 2023 (left). Floodmarks indicating high water levels during DANA 2023 (right).

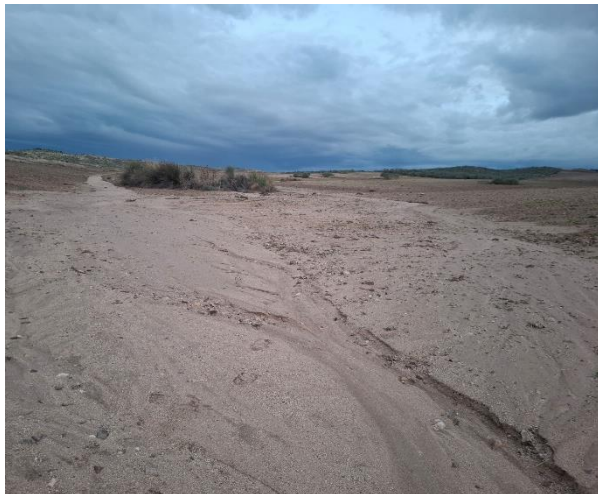
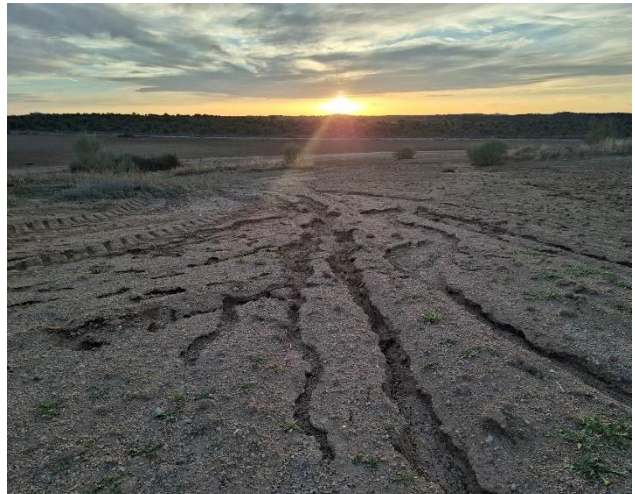
Figure 45: Streambed amidst fallow land (Left) Fresh erosion tracks highlight the vulnerability of this area to soil erosion and surface runoff (Right).

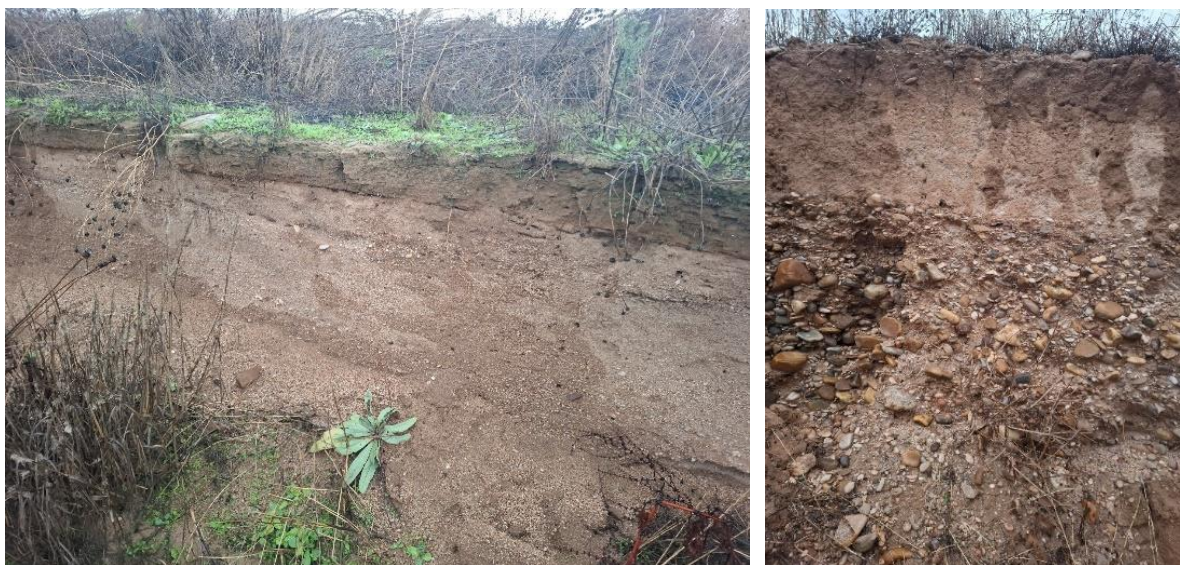
Figure 46: Alluvial deposits forming an aquifer layer (left), Conglomerate layers of sand and stone are vulnerable to erosion (right).

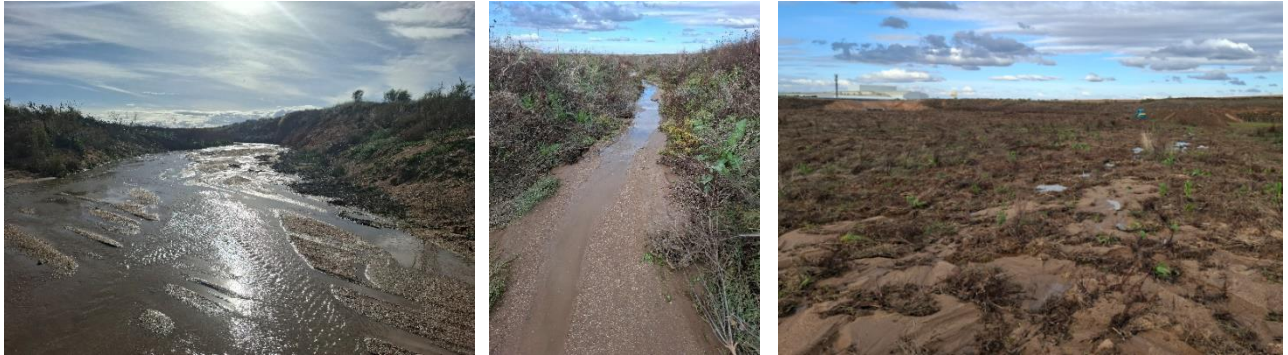
Figure 47: In the afternoon of 30 October 2024, the small discharge in the Ramabujas (left) was completely infiltrated 2 kilometres downstream (right).

The alluvial deposits of sand and clay form an aquifer layer that allows water from the Ramabujas to infiltrate. This area has the potential to serve as a water retention area for the Ramabujas (Figure 47).

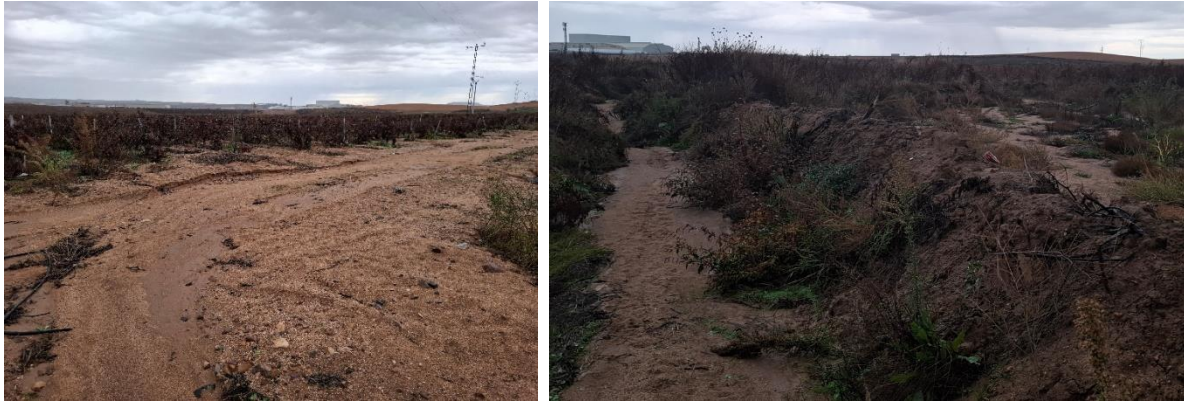
Figure 49: Sand deposits in the vineyard from the Arroyo del Quintillo de los Churros after DANA (left). An improvised dam bisecting the Ramabujas streambed to 'protect' the vineyard from flooding (right).

To protect the vineyard from future flooding, the farmer built an improvised dam around his parcel, bisecting the Ramabujas streambed (Figure 49). However, the dam will not be strong enough to withstand the force of the next DANA event.
