Natural Water Retention in the Ramabujas Stream catchment near Toledo

The road to reduce peak flows and increase infiltration

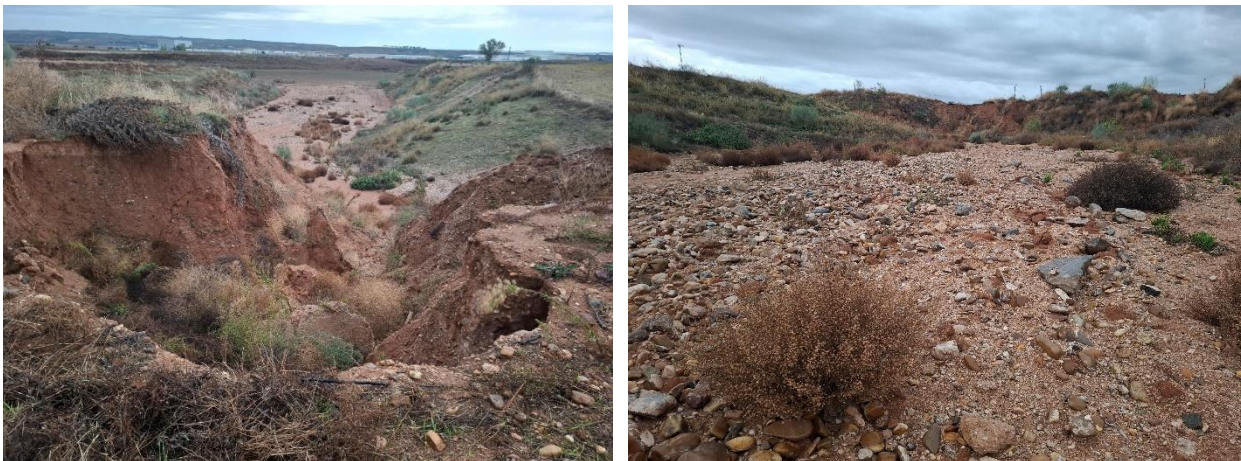
Figure 50: Severe erosion caused by high discharges and the vulnerable geological structure in this sub-catchment during DANA.

The soil structure of the Miocene stone conglomerates and sand layers is not very solid, making it vulnerable for severe erosion during a DANA event (Figure 50). High discharges from the small sub-catchment caused backward erosion, resulting in the transport of large stones over several hundreds of meters.

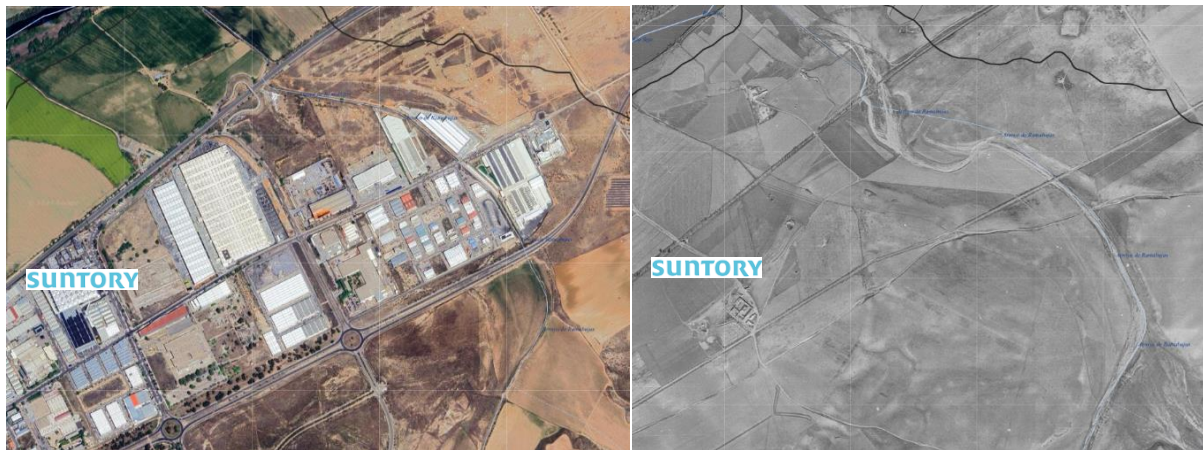
Figure 51: Location of the Suntory factory in the industrial site, with the Ramabujas canalised (left). The same location on the aerial photo of 1956, the Ramabujas at that time followed a natural course and had more space to handle high water discharges (right)

The Suntory factory is located in the industrial site of Santa María de Benquerencia, an area developed in the second half of the 20th century where the Ramabujas approaches the Tagus Stream (Figure 51). The Ramabujas was redirected into a channel, and culverts were constructed to allow water to pass under the highway and railway. After DANA 2023, the culvert under the highway was enlarged to increase its discharge capacity and prevent future flooding of the highway (Figure 52 left). However, the capacity of the canal remained unchanged, leaving the industrial site still vulnerable to flooding (Figure 52 right).

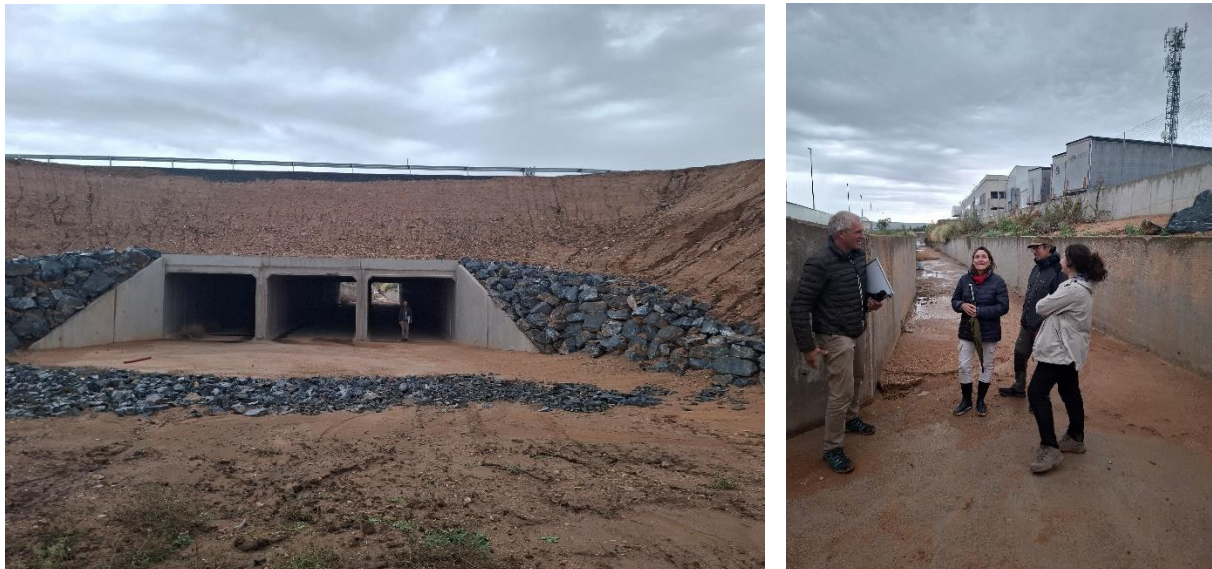
Figure 52: The new culvert construction under the TO-23 highway, with three passages, each having a flow area of 10 m². Downstream of the culvert, the canal has a flow area approximately half of the culvert's capacity.

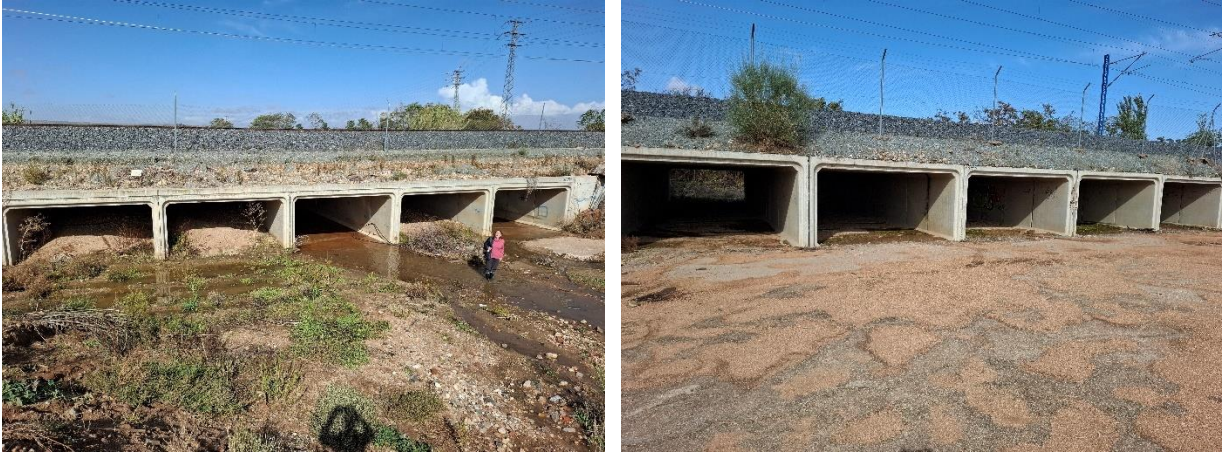
Figure 53: Two large culvert constructions under the railroad, each has five passages with a flow area of 5m².

And the end of the canal, close to the stream Tagus, two large culvert constructions transport the Ramabujas water under the railway (Figure 53). Both were discharging water during DANA.

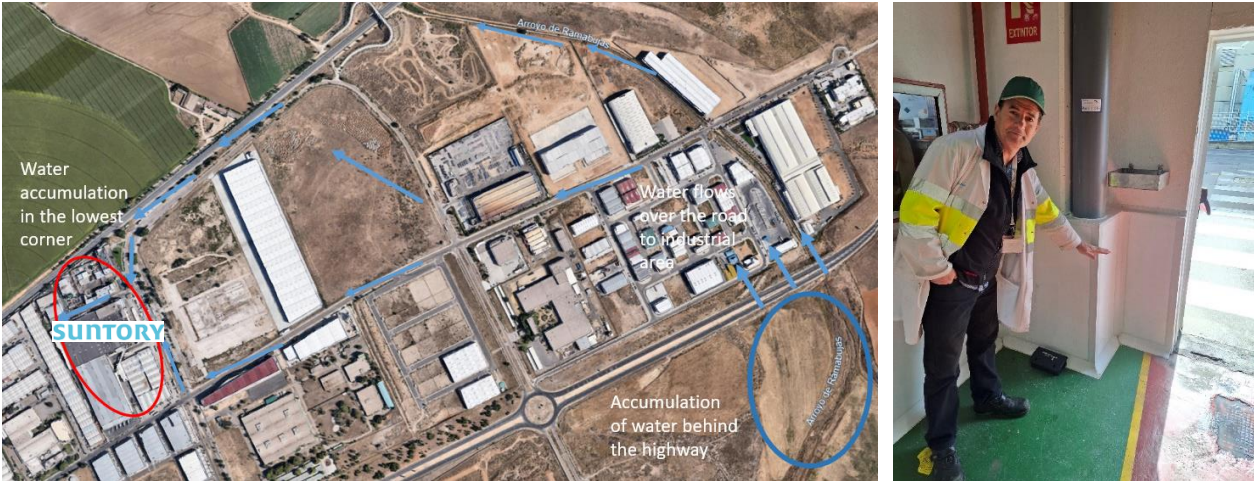
Figure 54: During DANA the water flooded the industrial site and accumulated in the lowest corner at the Suntory factory. Water levels exceeded 50 centimetres in both the factory and the Suntory water treatment plant.

During DANA, the industrial area was flooded, and water accumulated in the lowest corner near the Suntory factory site, at more than 1 kilometre distance from the Ramabujas (Figure 54 and 55). Water levels exceeded 50 centimetres in both the factory and the Suntory water treatment plant. Thick layers of mud were deposited in the factory, leading to its closure for two weeks. The small culvert construction under the railway near Suntory was unable to discharge the large volume of water, resulting in high water levels.

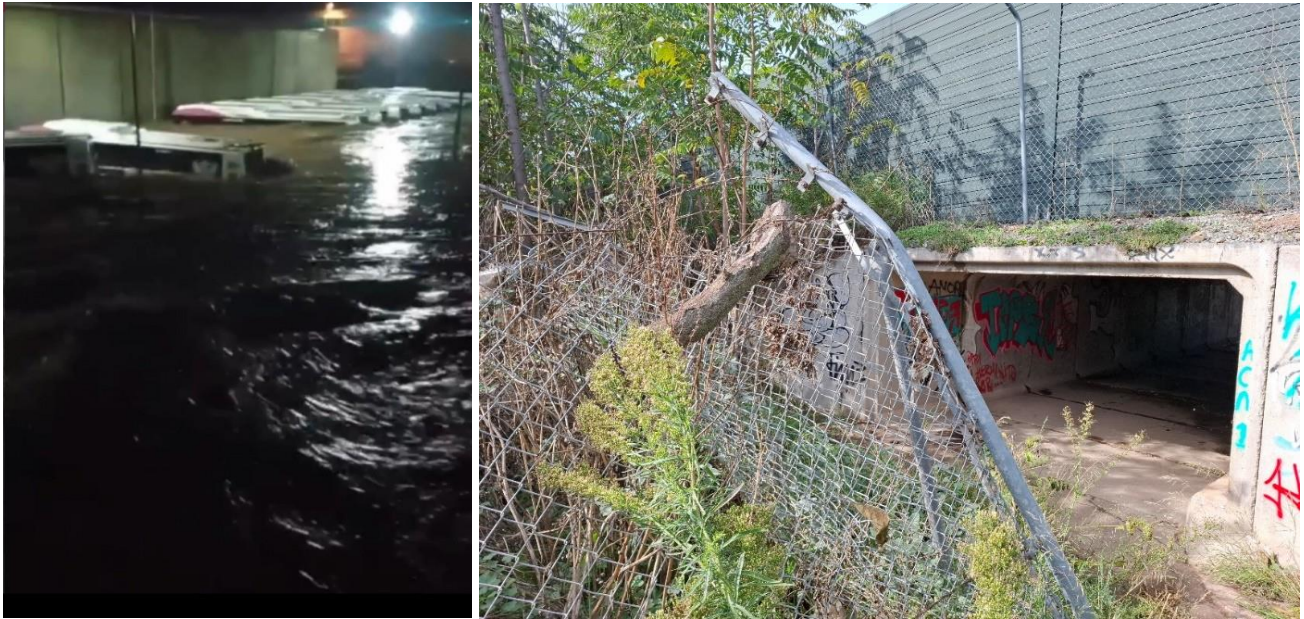
Figure 55: During DANA the Toledo bus terminal close to the Ramabujas was flooded (Left). Suntory, at more than 1 kilometre distance from the Ramabujas, was flooded as well. The culvert construction under the railway near Suntory was unable to process the flood water. The branch of a tree hanging in the fence indicate the water level during the flood (Right).

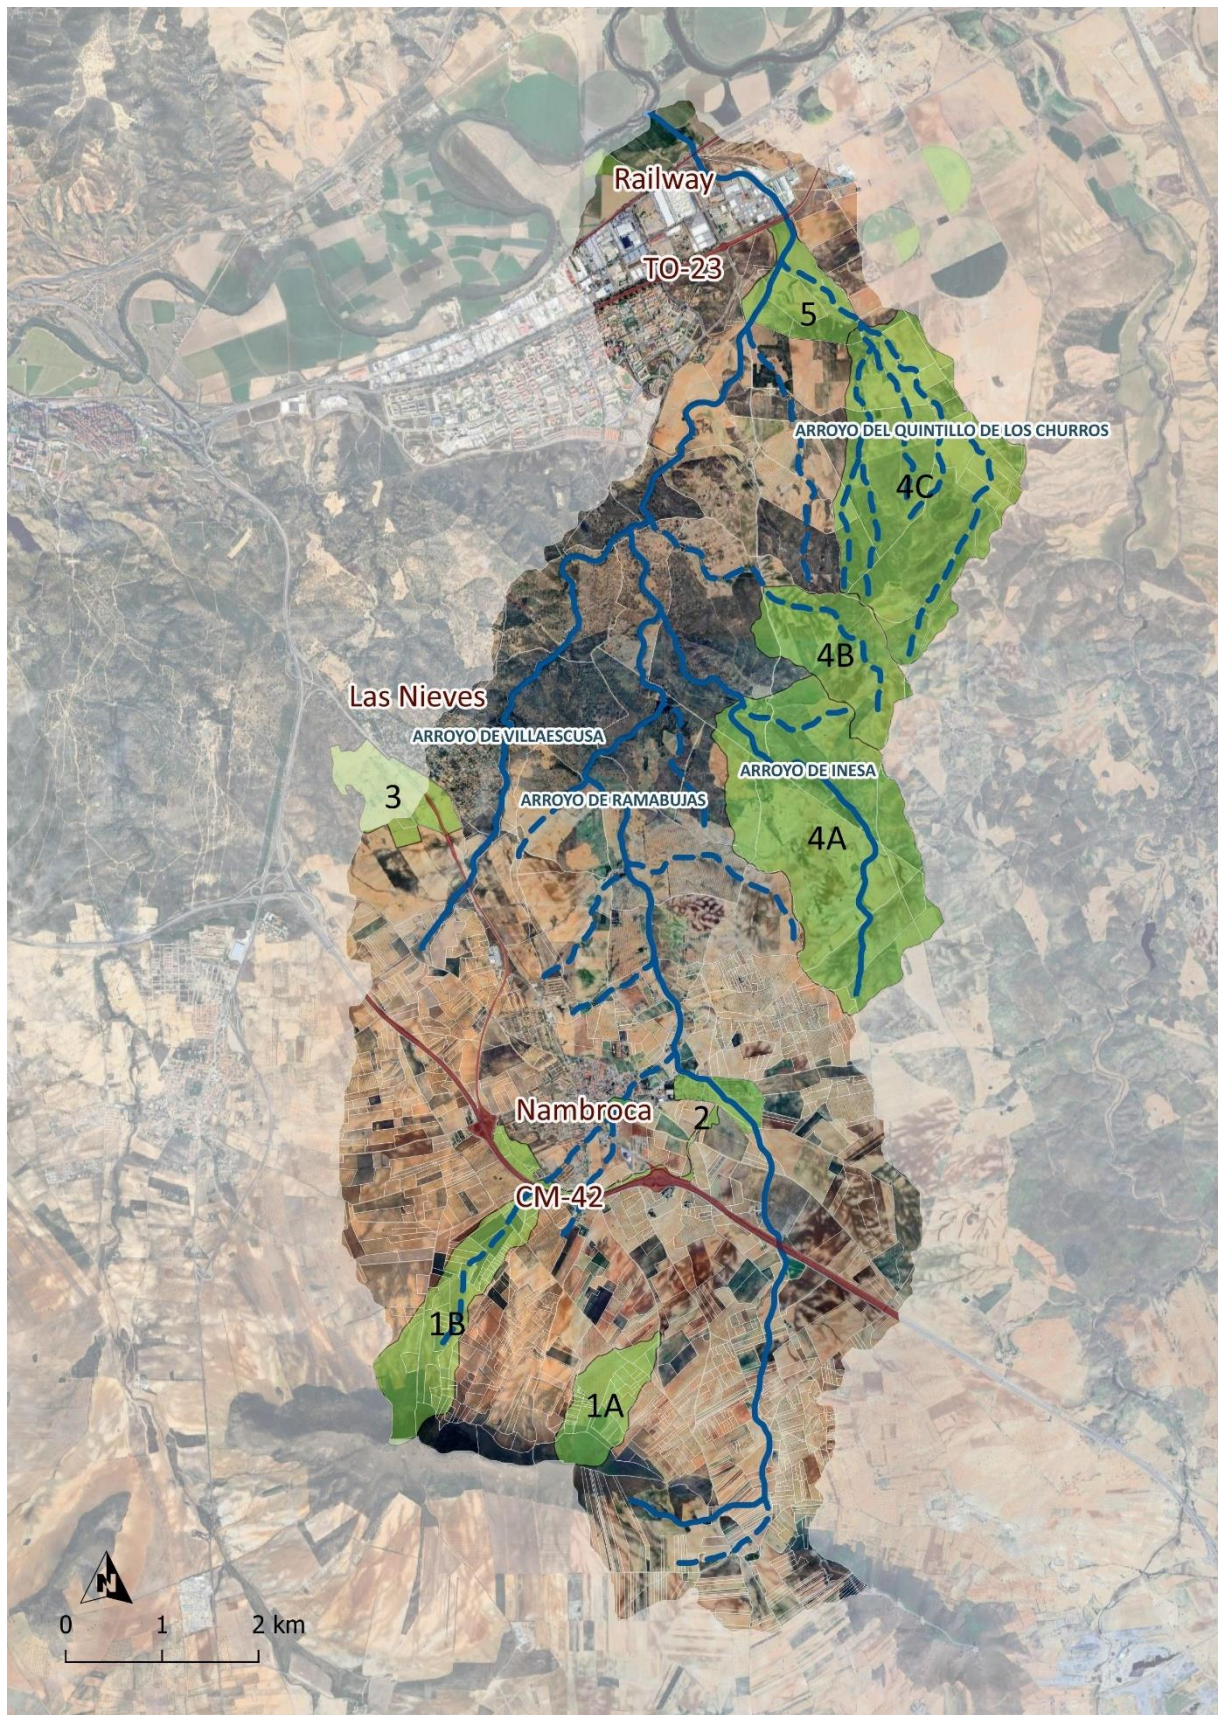
Figure 57: Catchment-scale map with overview of proposed water retention areas.

The areas where measures are recommended (15.3 km²) accounts for 22.6% of the total Ramabujas catchment (figure 57). The measures will be discussed in more detail in the following paragraphs.

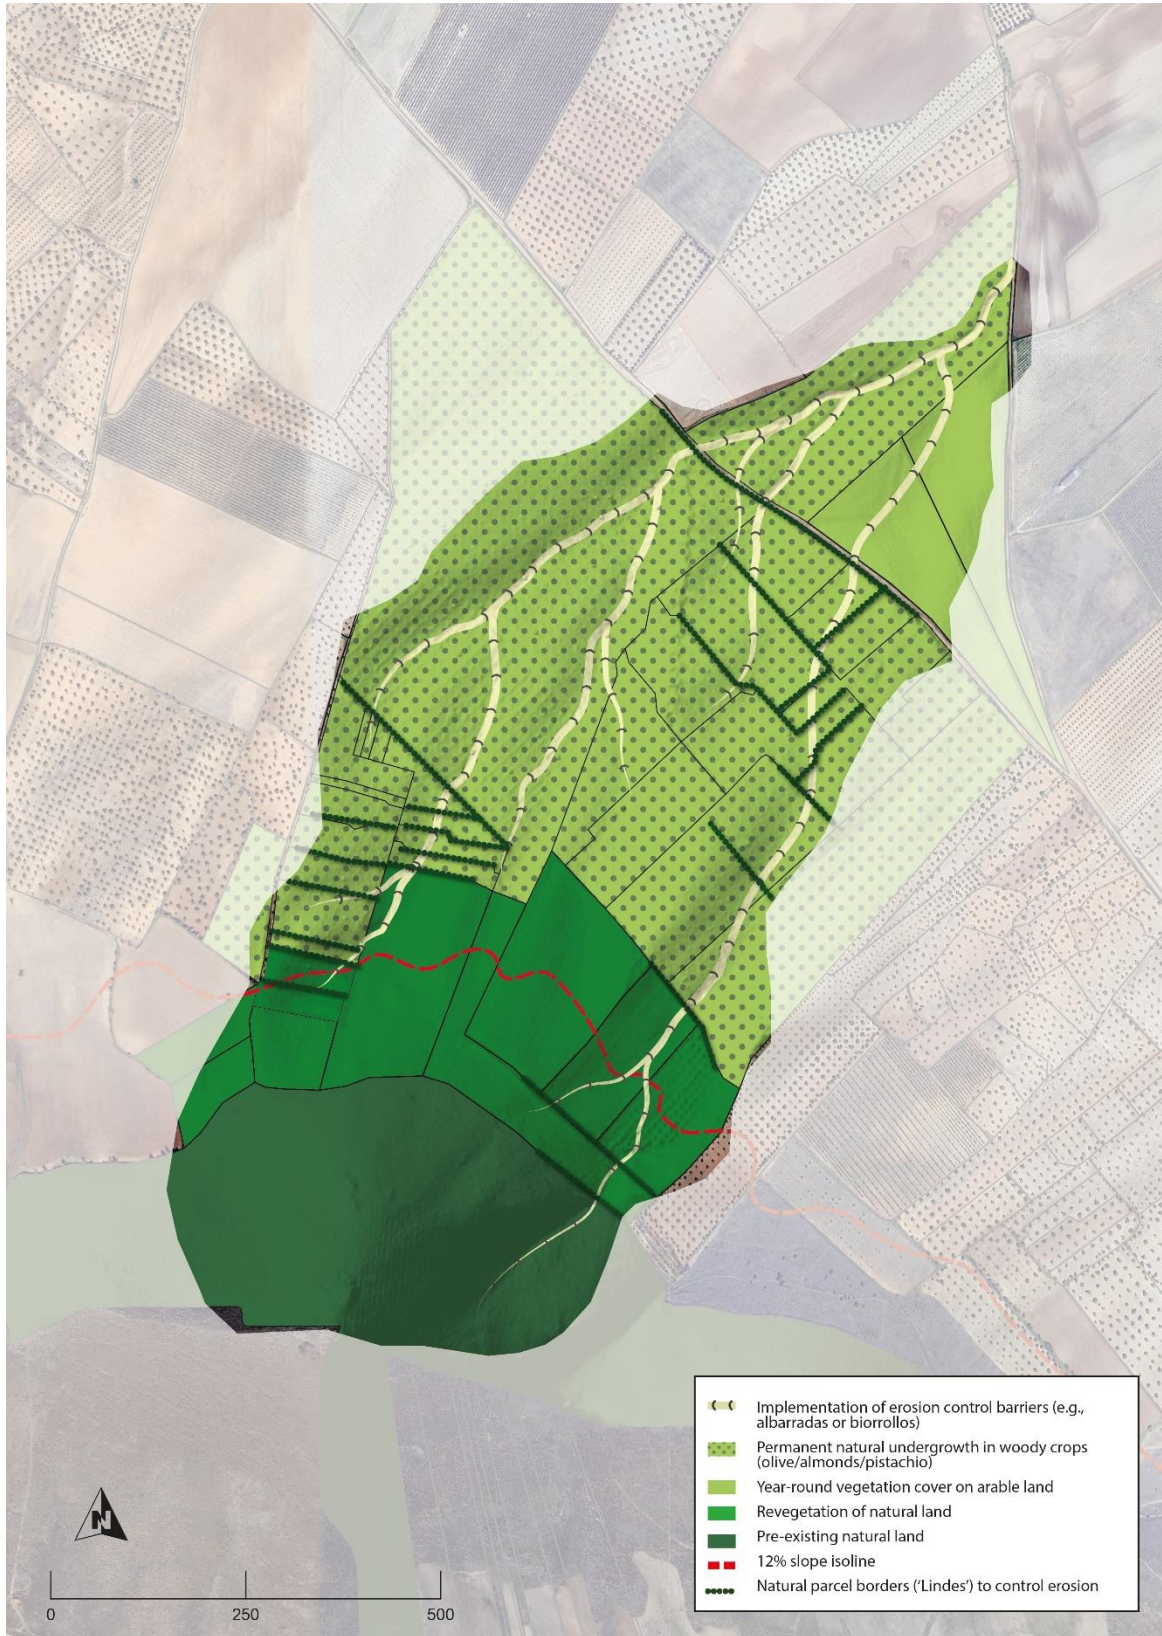
Figure 62: Water retention map of upstream area 1a.

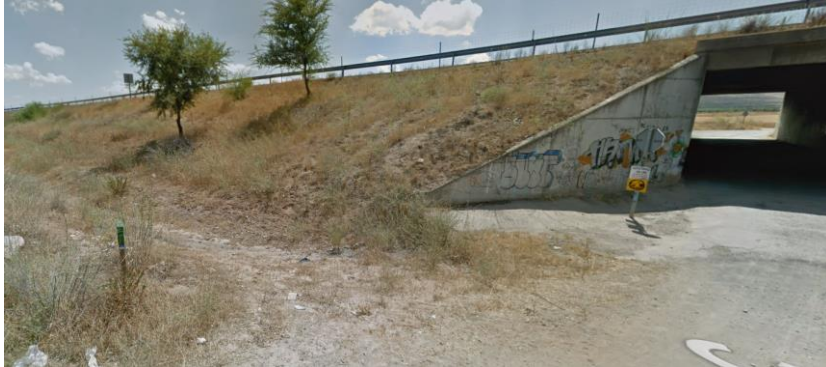
Figure 65: The start of the canal with a 90 degrees angle between the incoming water (through the tunnel) and the canal. In case of DANA much of the water will flow straight into the village instead of flowing into the canal.

In the current situation the artificial canal, who diverts the water around the village, is not up to the task of processing the water discharge during a DANA event. Probably this is caused by the narrow seize of the canal and due to of its sharp bends of sometimes 90 degrees which make the water flow not fluent (figure 65).

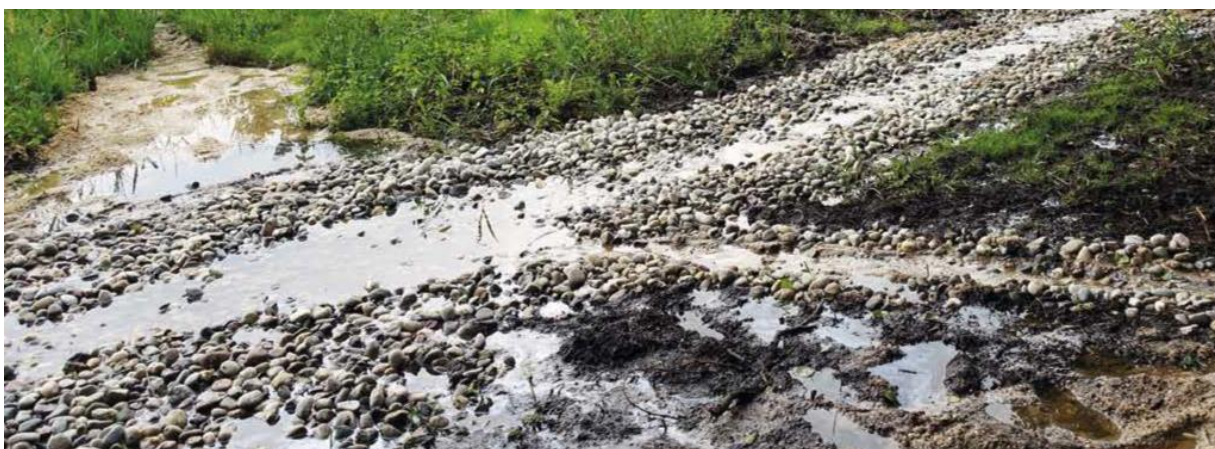
Figure 66: Raising the streambed with ca. 1 metre with stones or sediment in the retention area (3) will increase retention in that area and decrease flow velocity (Source picture: Ophogen beekbodems OBN)

The canal and the Ramabujas streams collide east of Nambroca (3), making it a perfect area for water retention to relieve downstream areas. In this area water discharge velocity is going to be slowed down to increase infiltration and increase the storage capacity. For the normal rain events erosion control barriers will slow down the runoff velocity and increase infiltration. Raising the streambed with 1 meter at a length of ca. 1 km will cause earlier flooding in case of a DANA event. When the area is flooded more easily, runoff water will temporarily be stored, and flow velocity will be decreased. The natural vegetation of herbs, plants and trees in the retention will decrease the flow velocity even further.

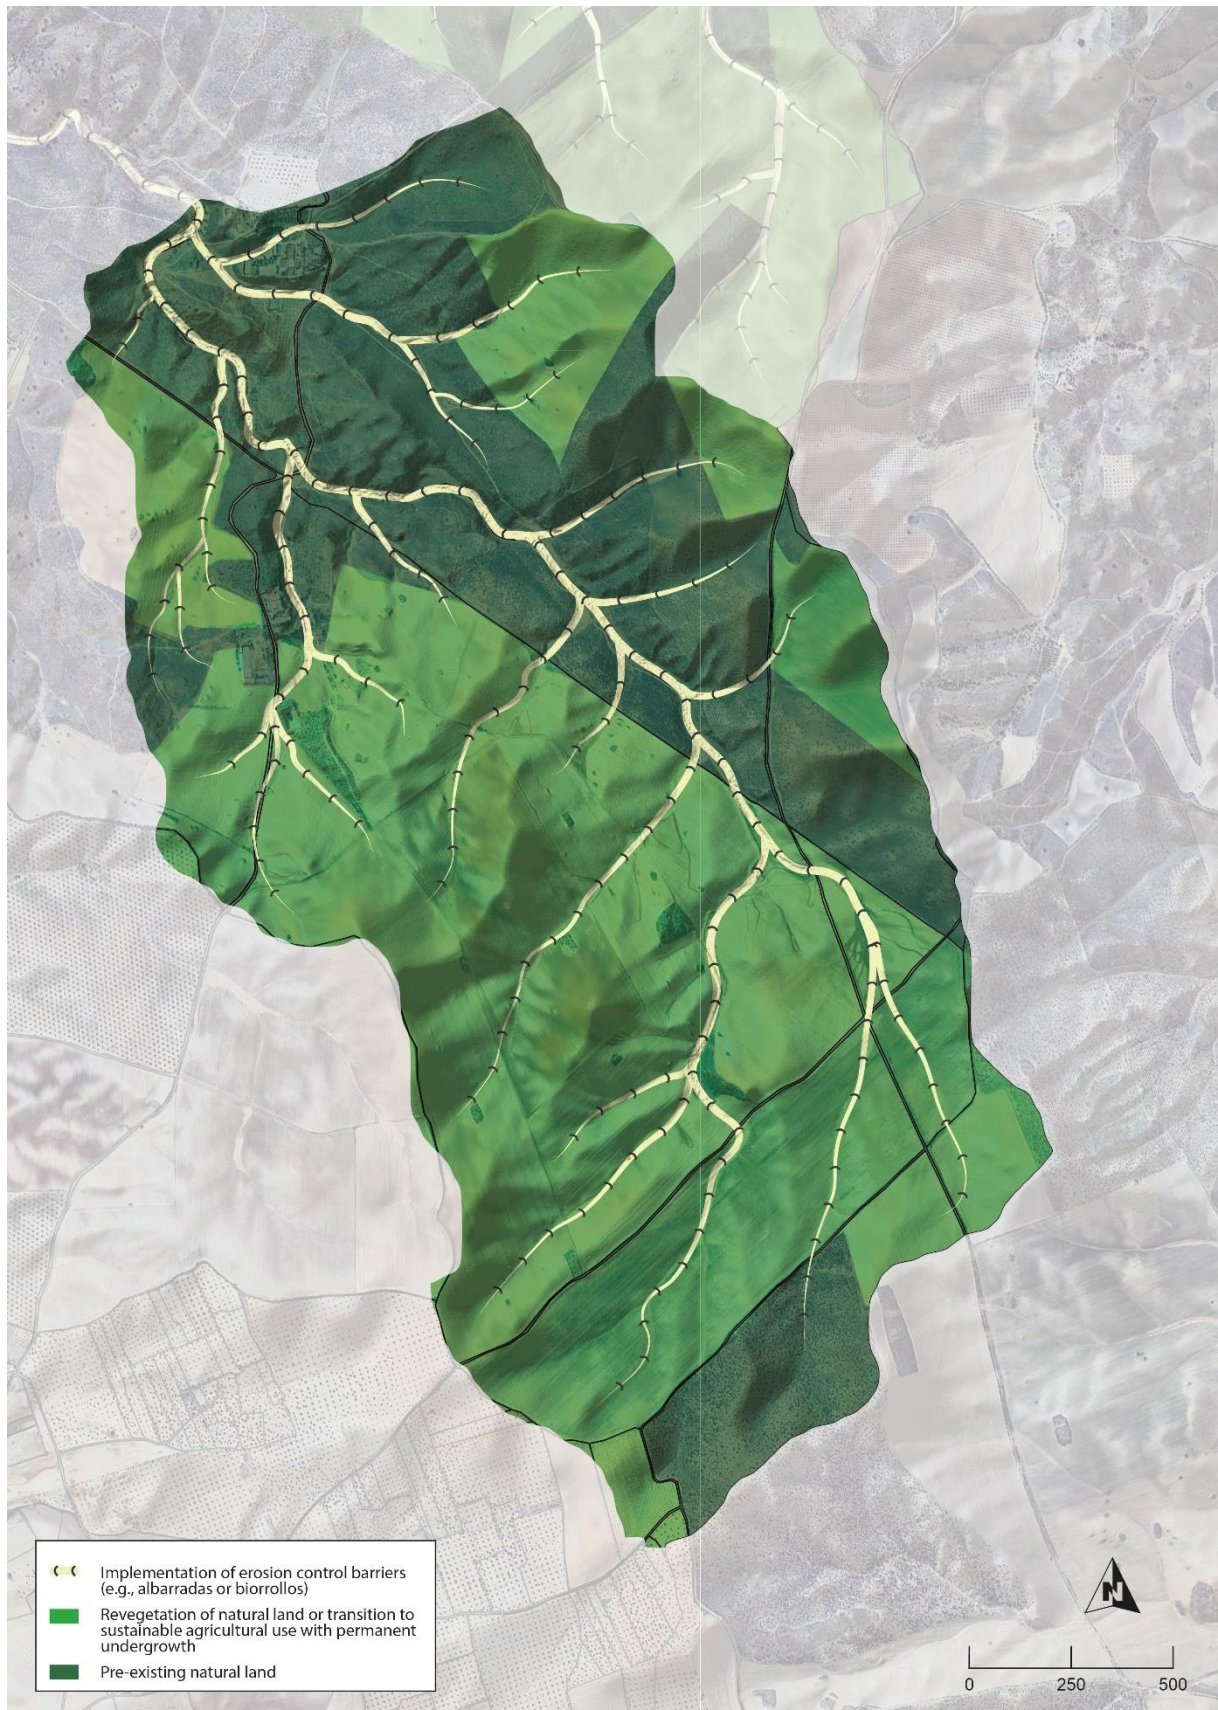
Figure 71: Water retention map of area 4a

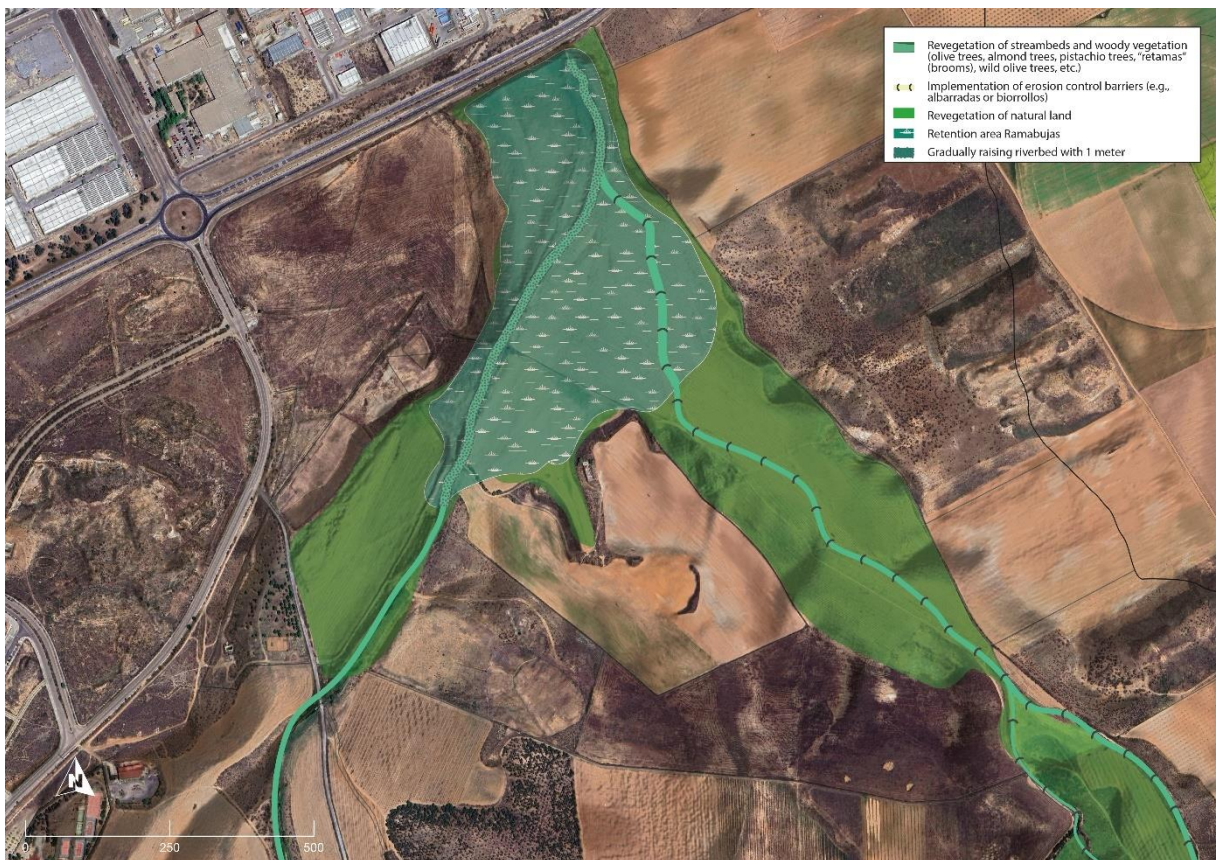
Figure 76: Water retention map of area 5

By raising the streambed, the Ramabujas will sooner flood its banks which decreases flow velocity and increases infiltration. The Arroyo del Quintillo de los Churros will be able to flow in a natural vegetated area with erosion control measures decreasing its discharge velocity.
