Successes of EU Water Framework Directive

implementation

Evidence of river restoration measures improving ecological

conditions

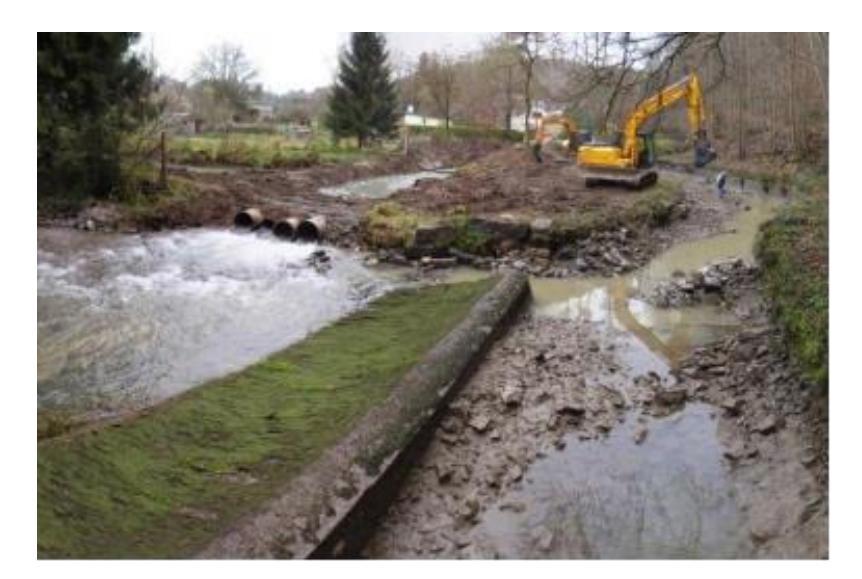
Figure 1. Works for weir removal at Spontin (source: LIFE project «Walphy» Layman's report).

Monitoring activities showed that the habitat heterogeneity was enhanced, with a consequent improvement of the ecological conditions in most of the study sites. Significant examples are the weir removal at Spontin and the remeandering in Emptinale along the Bocq. At the Spontin site an improvement was observed of the number of rheophilic species, biomass and number of individuals. In addition, the value of the biotic index of fish integrity (IBIP, indicating the ecological quality based on the attributes of fish communities) moved from 19 to 23, i.e. from good to high quality class. On the other hand, no significant improvements were measured through the sampling of benthic macroinvertebrates. At the remeandered site in Emptinale, a significant improvement was observed of both the benthic macroinvertebrates-based index IBGN (Indice Biologique Global Normalisé, indicating the ecological quality for benthic macroinvertebrates) from moderate to good quality class and the fish-based index IBIP from good to high quality class (Castelain et al., 2018).

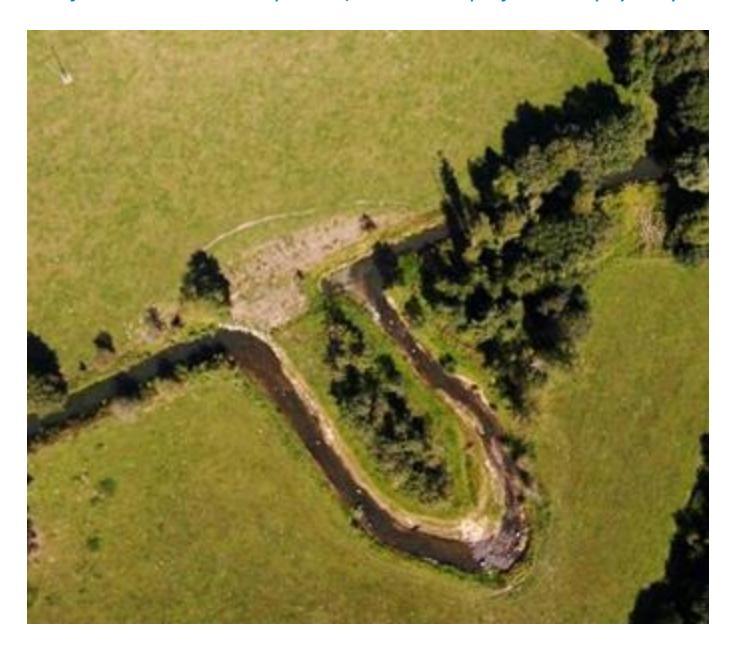
Figure 2. Re-meandering of the Eau Blanche at Boussu-en-Fagne (source: LIFE project «Walphy» Layman's report).

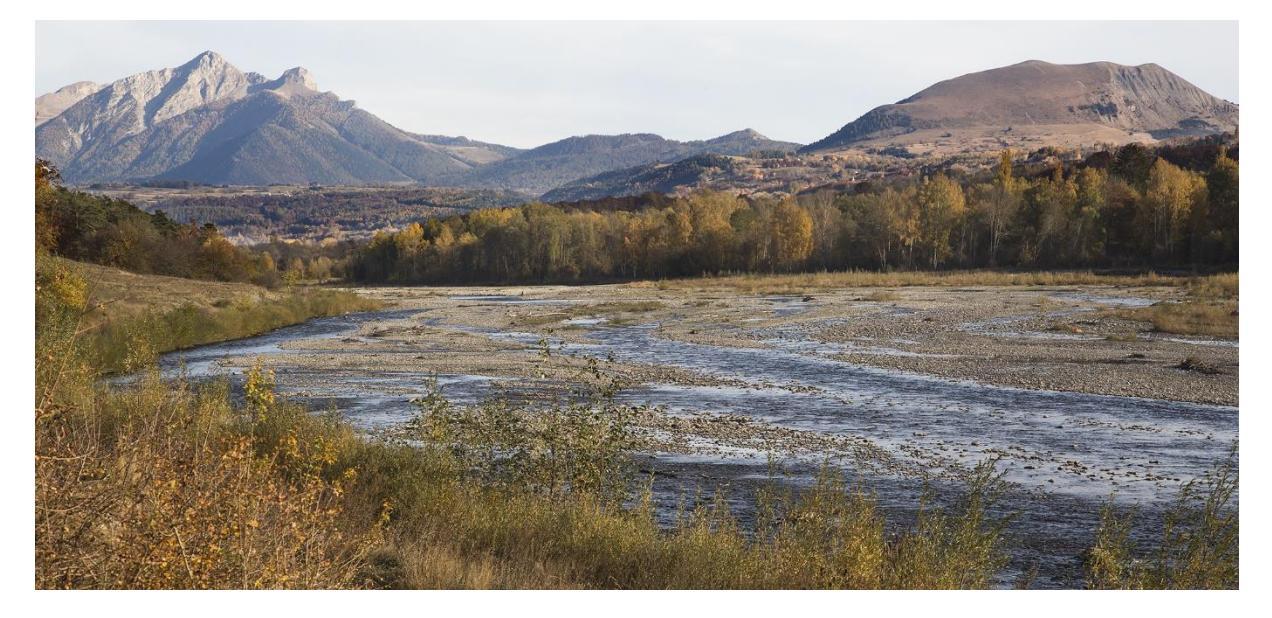
Figure 3. The Drac in the restored reach (October 2017, picture by Bruno Boz).

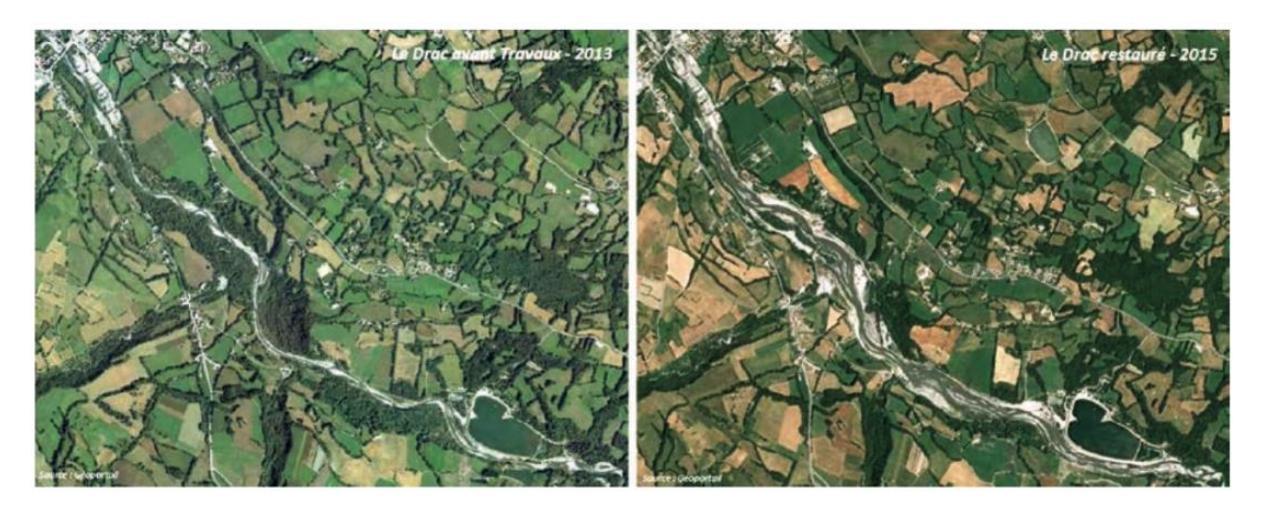
Figure 4. On the left panel, aerial view on the single channel Drac prior the 2013 intervention; the Champsaur dam can be recognized in the bottom right corner. The river flows towards the top of the picture. On the right panel, the same reach after the intervention (source: French geoportal).

Several elements were considered in the assessments carried out before the intervention, ranging from morphodynamics, to habitats and aquatic fauna. The project established a 10-year monitoring program on morphology and ecology. Innovative monitoring methods are planned for evaluating the evolution of the channel morphology: bedload tracing program using active ultra-high frequency RFID technology, repetitive high-resolution topographic surveys of the restored reach and high-frequency qualitative survey of channel changes using time-lapse cameras. The first morphologically relevant flood (15/11/2015) triggered the development of braided channel morphology.

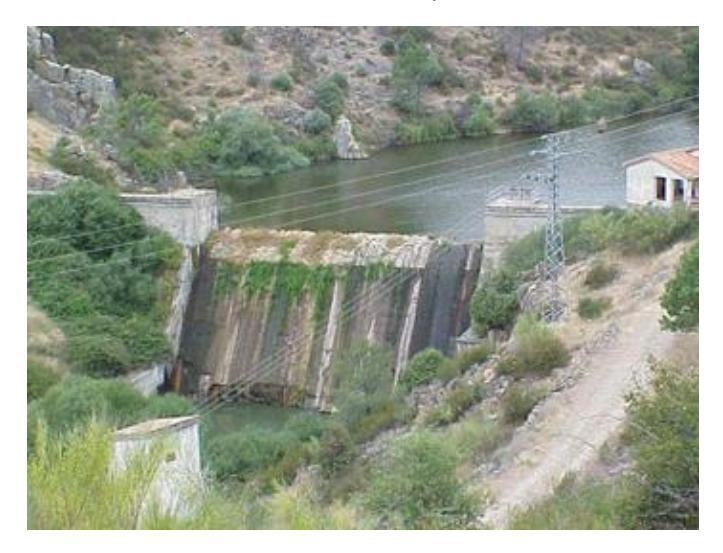
Figure 5. The Robledo de Chavela dam (source: Tajo River Basin Authority – Confederación Hidrográfica del Tajo).

This study is part of the river restoration project of the Cofio River (Madrid) after the demolition of the dam of Robledo de Chavela. This dam was built in the 1960s for the supply of potable water for the municipality, coming into operation in 1968. In 1990, due to problems of water quality, derived from discharges of livestock of upstream origin, it was decided to change the supply of the municipality and the dam was in disuse. In 2004, the Tajo Hydrographic Confederation recovered the ownership of the dam due to the expiration of the use and its state of evident abandonment. In the spring of 2012, leaks began to occur in the bottom drainage of the dam and, as a matter of urgency, a series of measures were implemented to prevent water contamination and to alleviate the effects on the river ecosystem. Finally, in September 2014, the dam wall was removed.

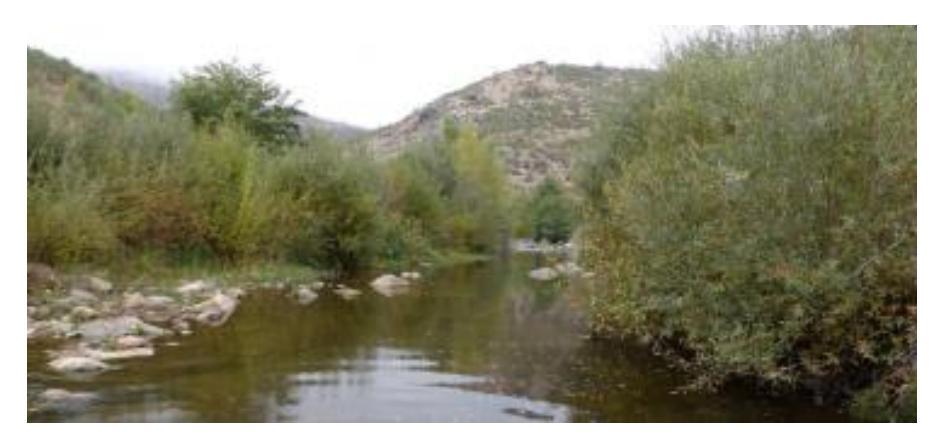
Figure 6. Riparian vegetation inside the old reservoir in 2018 (source: Tajo River Basin Authority – Confederación Hidrográfica del Tajo).

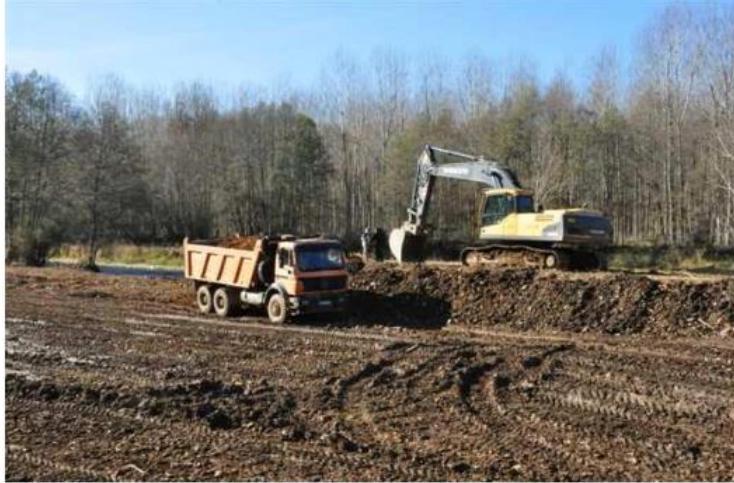
Figure 7. An artificial levee is lowered to recover lateral connectivity (source: Duero River Basin Authority – Confederación Hidrográfica del Duero).

Rock armoring of river banks and earth embankments were removed from more than 13 kilometers of river channels. Some earth embankments were set-back along 5 kilometers of river channels, and other barriers such as groynes were lowered. 10 kilometers of secondary arms were reconnected and/or directly restored. Moreover, a riverbank vegetation buffer was created along 7.2 hectares that were reconnected to the river. Other in-channel obstacles, namely weirs, were modified to restore continuity for fish fauna and sediments. The project approach was very different from the experience of the local stakeholders, who were initially reluctant, especially towards expropriation. However, an active public participation process was set in place, involving stakeholders in 50 meetings during 3

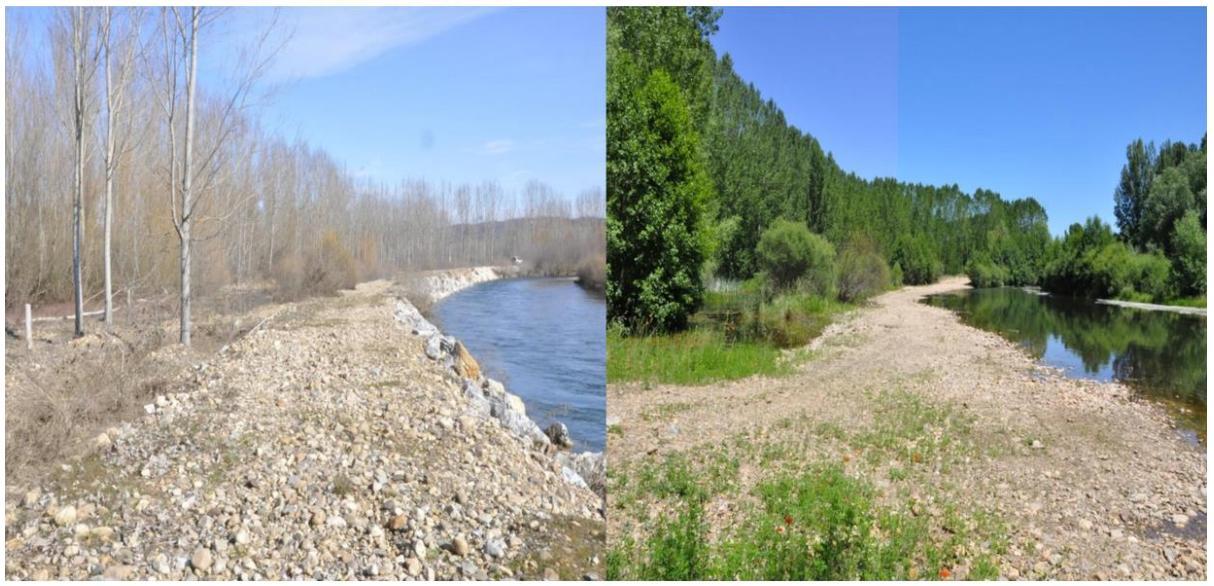
Figure 8. River bank protections were also removed along the river: on the left, the situation before the project; on the right, the river is reconnected to its floodplain (source: Duero River Basin Authority – Confederación Hidrográfica del Duero).

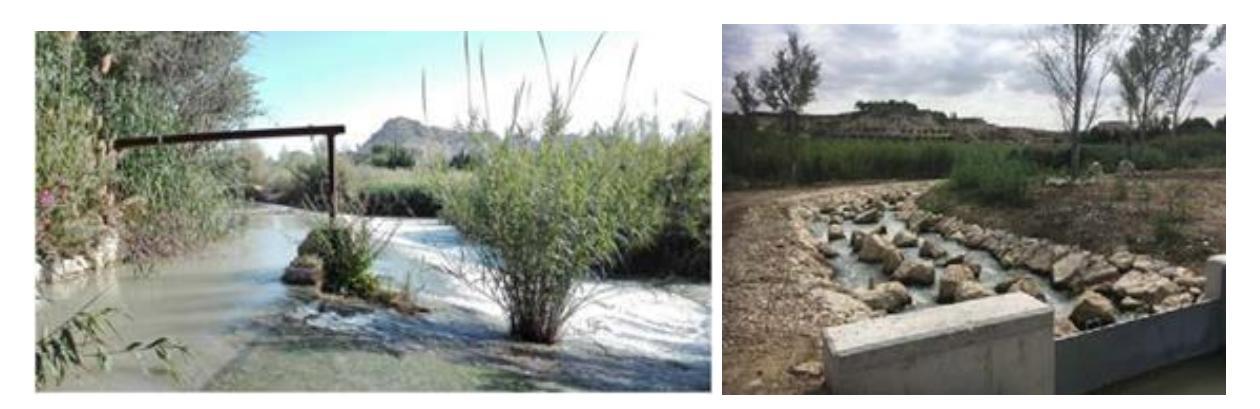
Figure 9. Azud Archena weir, on the left, and lateral fish bypass for Archena weir, on the right (source: Segura River Basin Authority – Confederación Hidrográfica del Segura).

The measures of the project consisted in the removal of one weir, the construction of 8 fish passages, the removal of 65 hectares covered by invasive plant species and the plantation of 2.200 trees and 4.800 shrubs along the river corridor. Moreover, 10 custody agreements with local farmers were signed and 7.000 students were volunteering in restoration activities and environmental education.

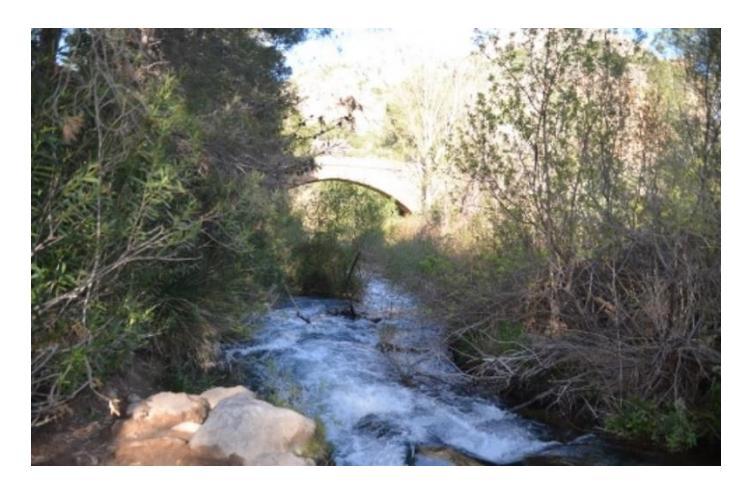
Figure 10. Restored flow along the Turia River (source: Pedro Merino Monzonis /RÍOS CON VIDA - Comunidad Valenciana).

The measure established a minimum ecological flow of 1.20 m³ to allow the recovery of the hydrological conditions and riverine communities.

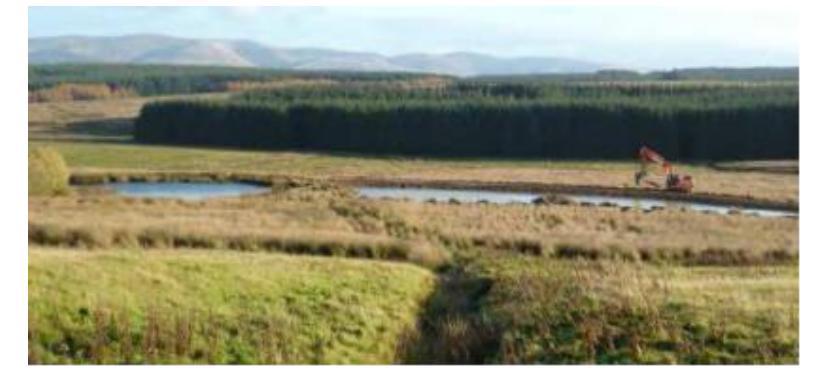
Figure 11. Construction of new ponds in the upper catchment (source: Eddleston Water Interreg Project Report 2016).

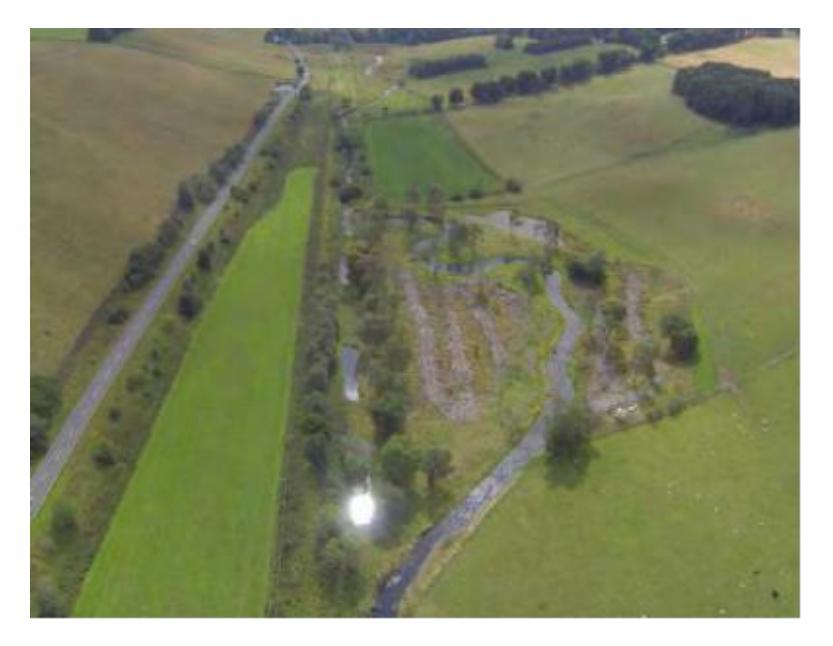
Figure 12. Re-meandered section of Lake Wood, with the old channel on the left (source: Eddleston Water Interreg Project Report 2016).

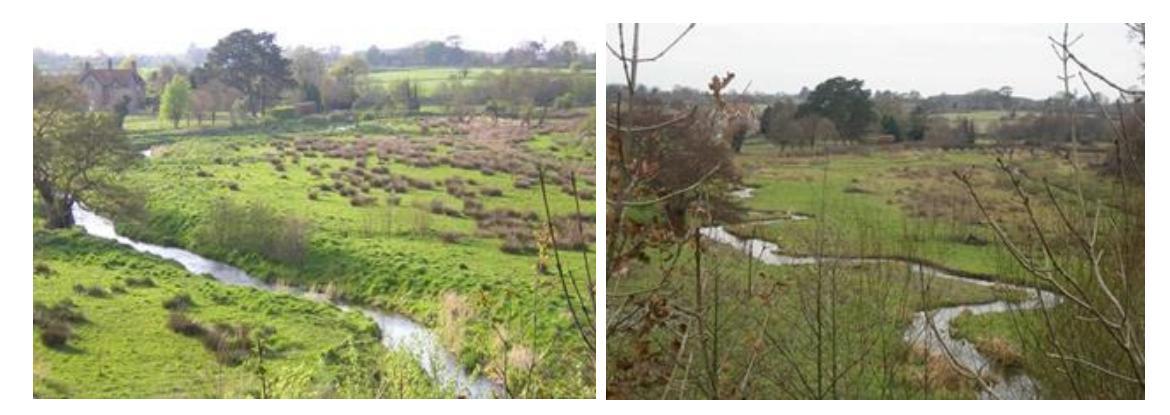
Figure 13. Re-meandered reach of the River Glaven at Hunworth: (a) In January 2009, prior to the rehabilitation project, on the left, and in December 2010, after re-creation of meanders in August on the right (source: modified by Champkin et al., 2018).

Embankment removal and remeandering alongside the River Glaven at Hunworth has created a more natural flood-pulsed hydrological regime, characterised by regular, short duration inundation of the floodplain meadow, with consequent positive effects for river–floodplain ecosystem functioning (e.g. enhanced habitat connectivity and heterogeneity). Before and after control intervention (BACI) surveys of floodplain plants, aquatic macrophytes, benthic invertebrates and fish were carried out, but some results are still to be published. Vegetation surveys recorded a significant increase in macrophytes' richness following the 2 phases of restoration. Remeandering at Hunworth Meadows had no significant impact on stream invertebrate biodiversity, but when invertebrates in backwaters along the floodplain were included, a significant increase in invertebrate diversity was detected, due to the addition of several 'pond-associated' species (Sayer 2014). The backwaters were also colonised by amphibians and these observations demonstrate that the presence of these standing waters significantly enhanced biodiversity in the river–floodplain system. Restoration interventions increased the density and biomass of brown trout (*Salmo trutta*), but had no significant short-term impact on other fish populations (Champkin et al., 2018).
